NSW EPA Site Audit Report Rushes Creek Poultry Production Farm AL005

Prepared for ProTen Pty Ltd

March 2022

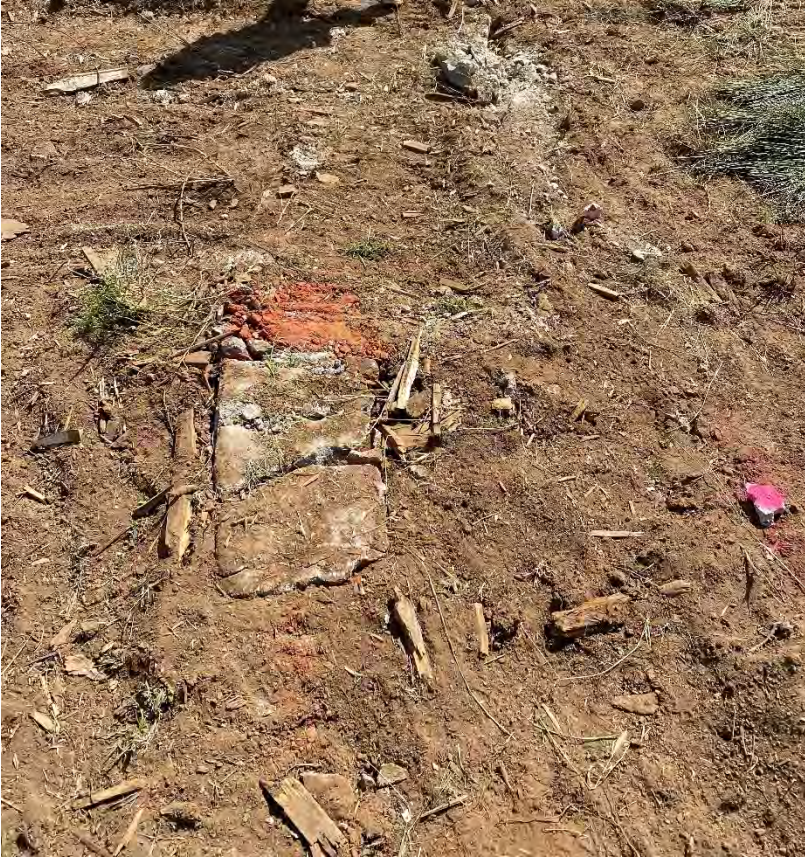
Figure 1 Stated Location of former concrete Sheep Dip

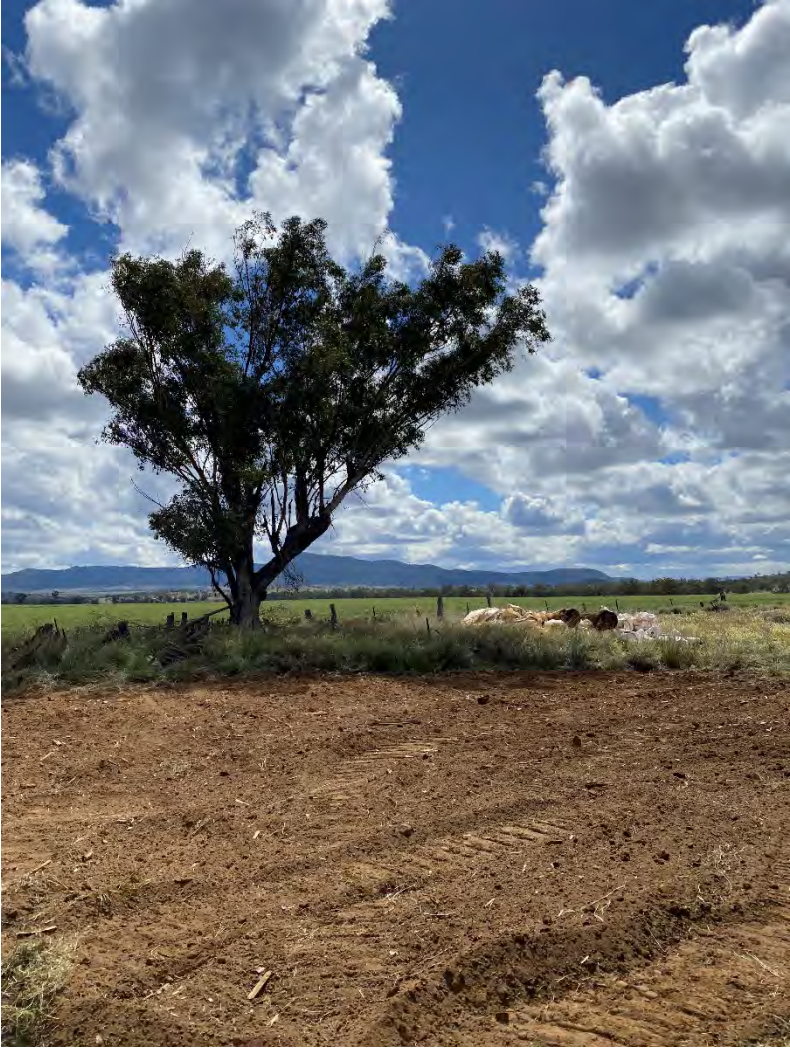
Figure 2 Soil on the footprint of the former shed after it had been demolished looking north east.

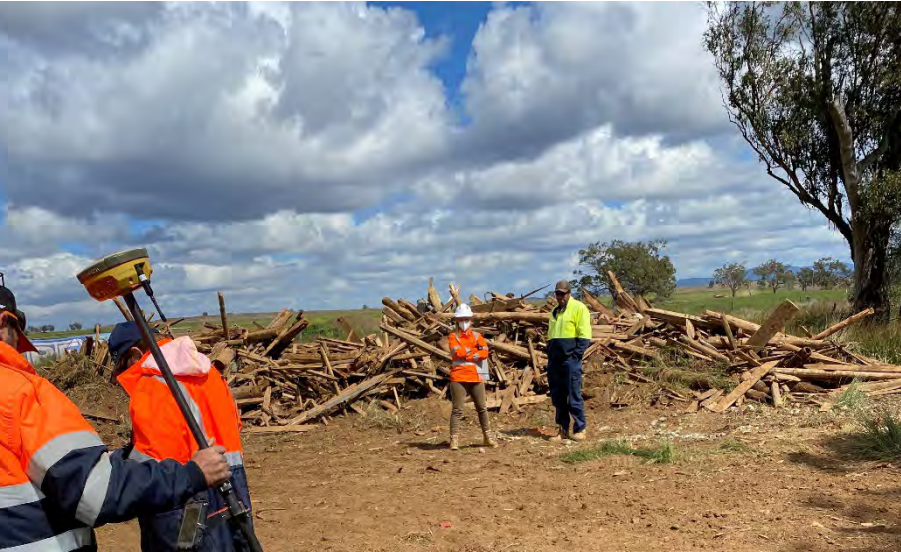
The Auditors representatives noted during the site inspection on 21 September 2021 that there were timber materials from the demolition of the sheep holding pens stockpiled within the centre of the capped extent.

The Auditor sought clarification on to the treatment of these piles before placement under the cap. If un-treated these materials may cause a depression of the cap and therefore potentially cause cracking and preferential pathways for water ingress.

Figure 3 Timber from demolition of shed, to be used as capping material looking west. TPE facilitating the collection of GPS coordinates with the GPS Rover.

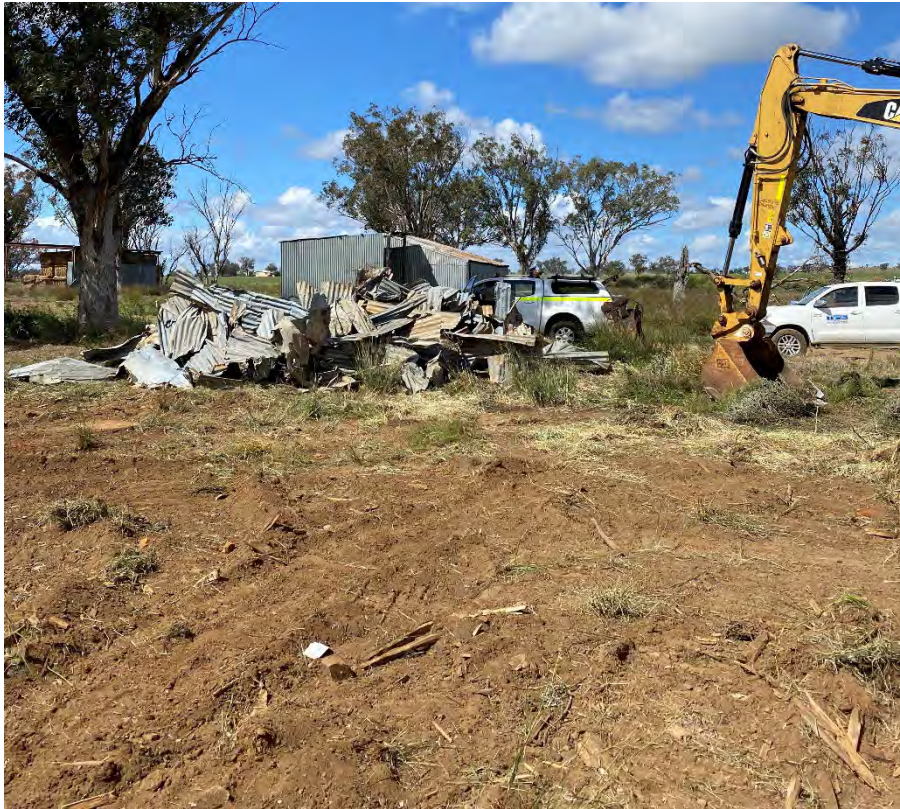
Figure 4 Metal from demolition of shed looking south.

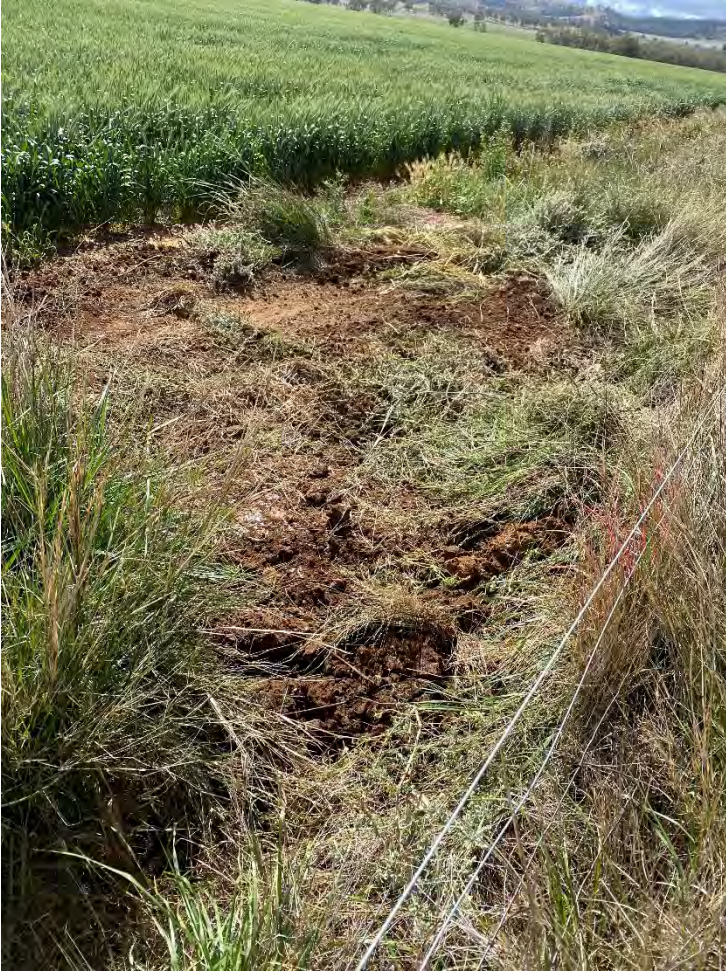
Figure 5 Test pit on other side of fence to the north of the site

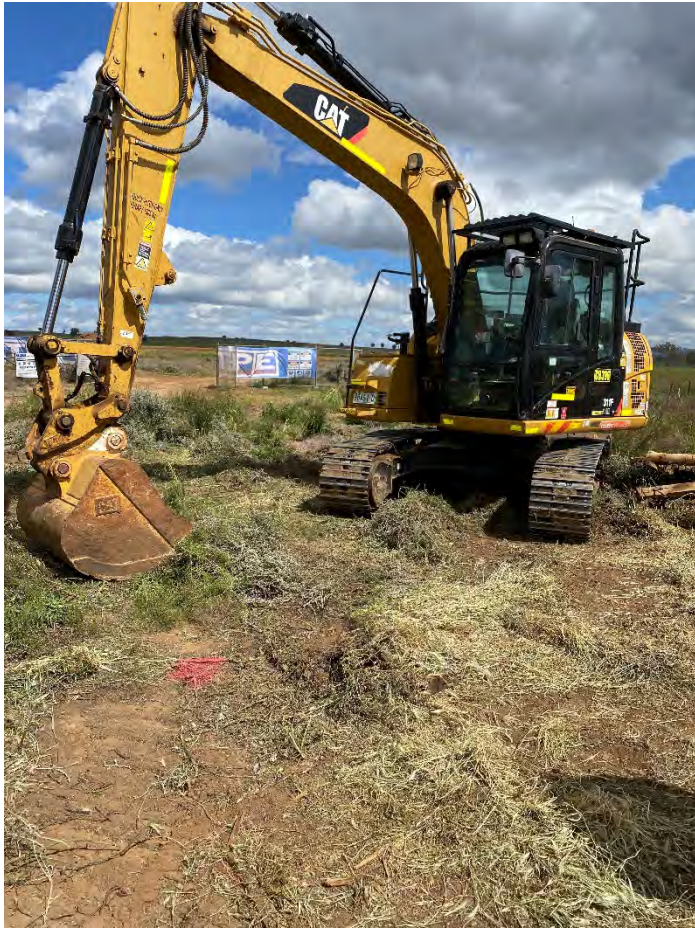
Figure 6 Pink paint marking the location of the TP201 to south of the source area.

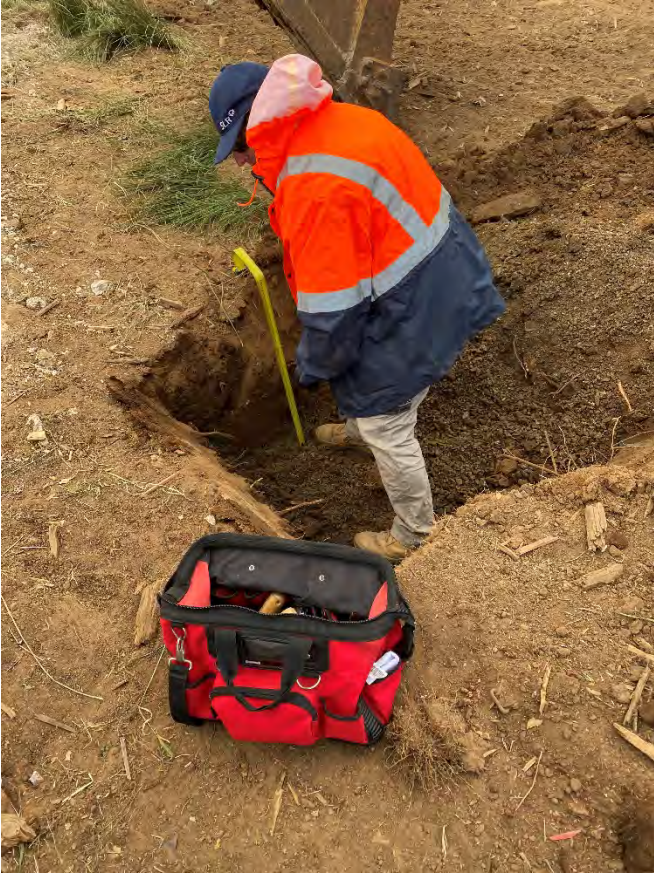
Figure 7 Sampling of test pit TP101

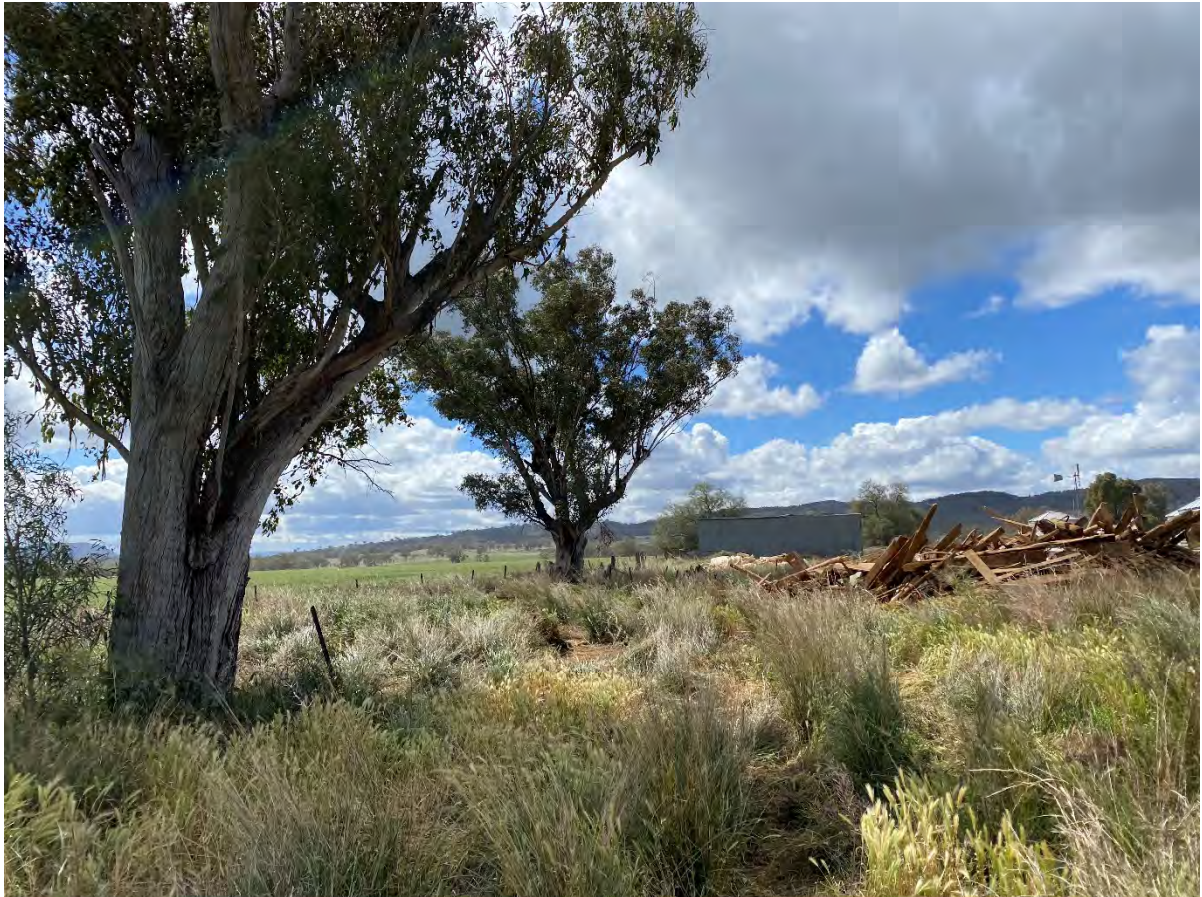
Figure 9 Tree in foreground stated to require removal due to location within the proposed cap area looking east.

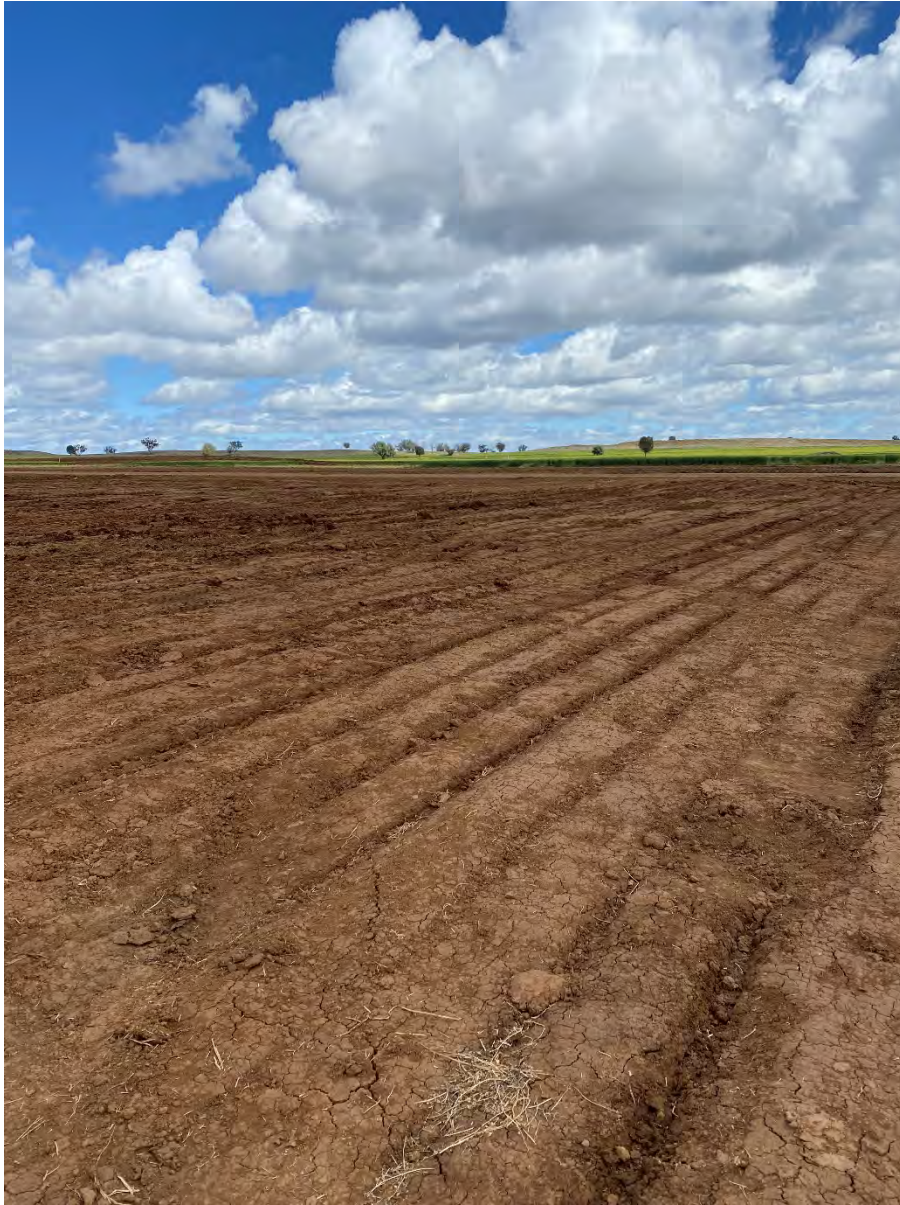
Figure 10 General area of where capping material is being sourced from on site

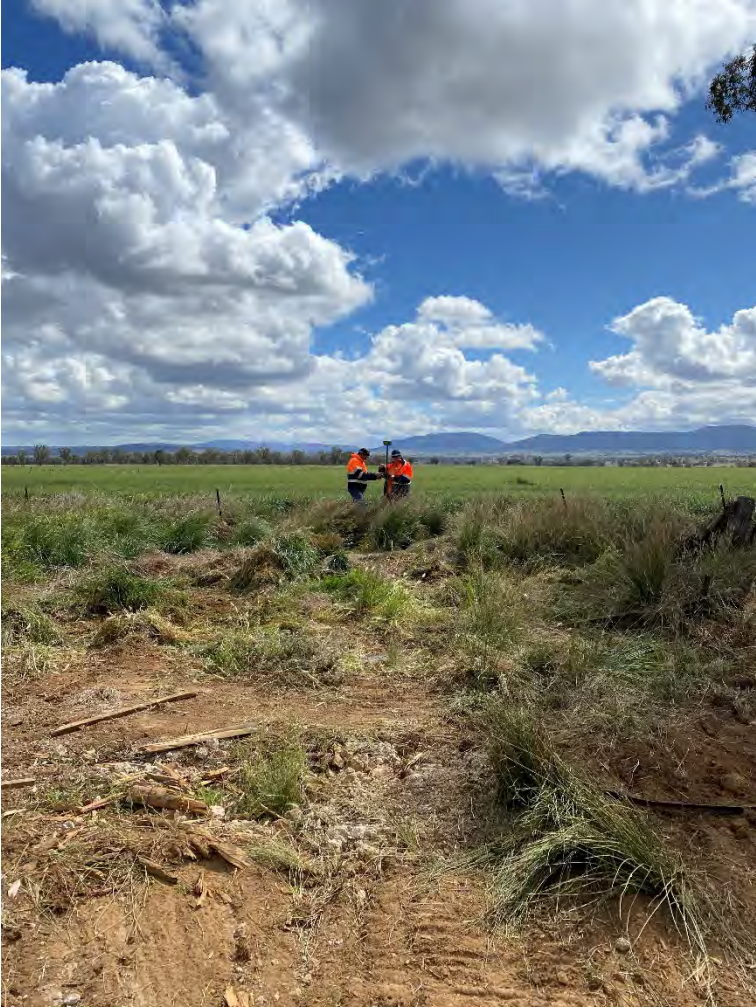
Figure 11 GPS locations of test pits being recorded unknown test pit nomenclature.

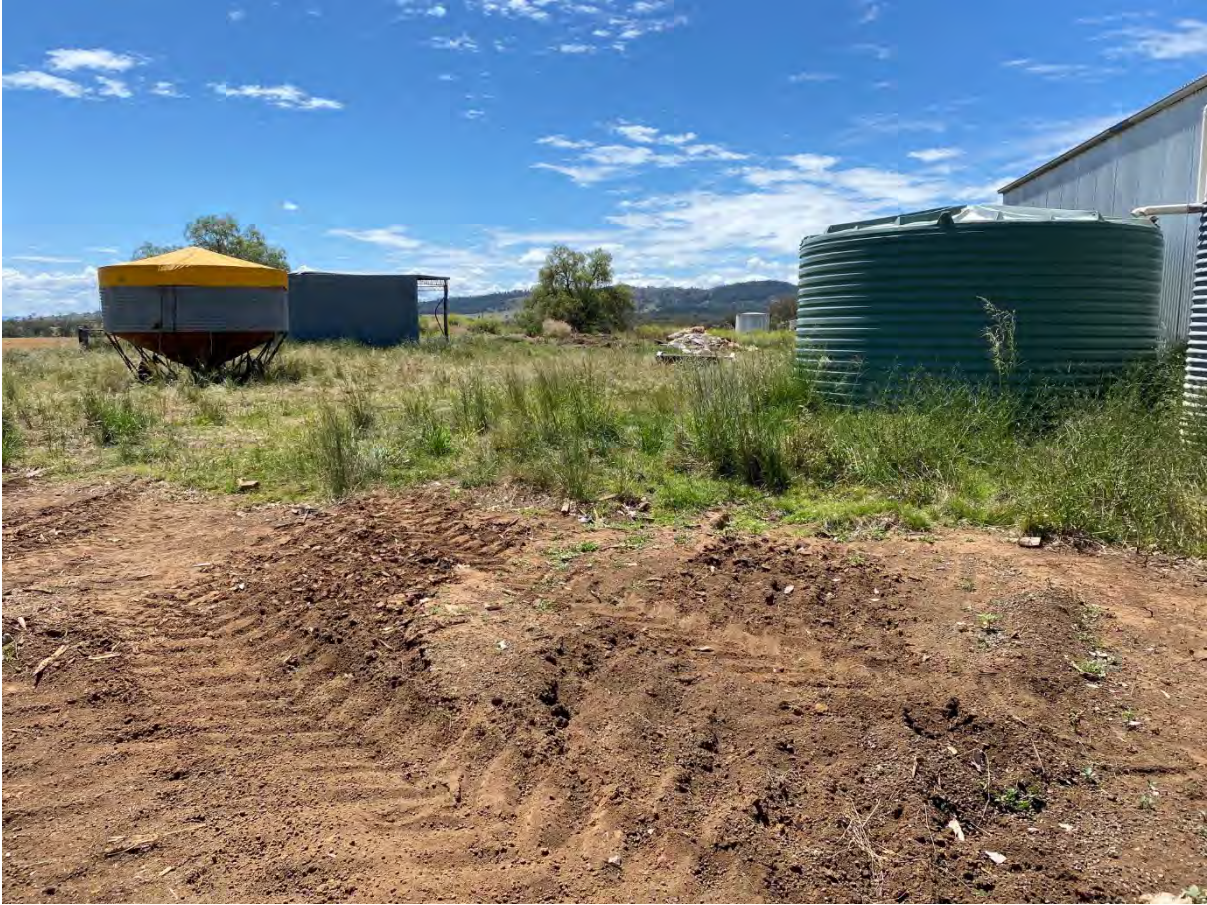
Plate 1 looking west from the CAP on the former shed extent.

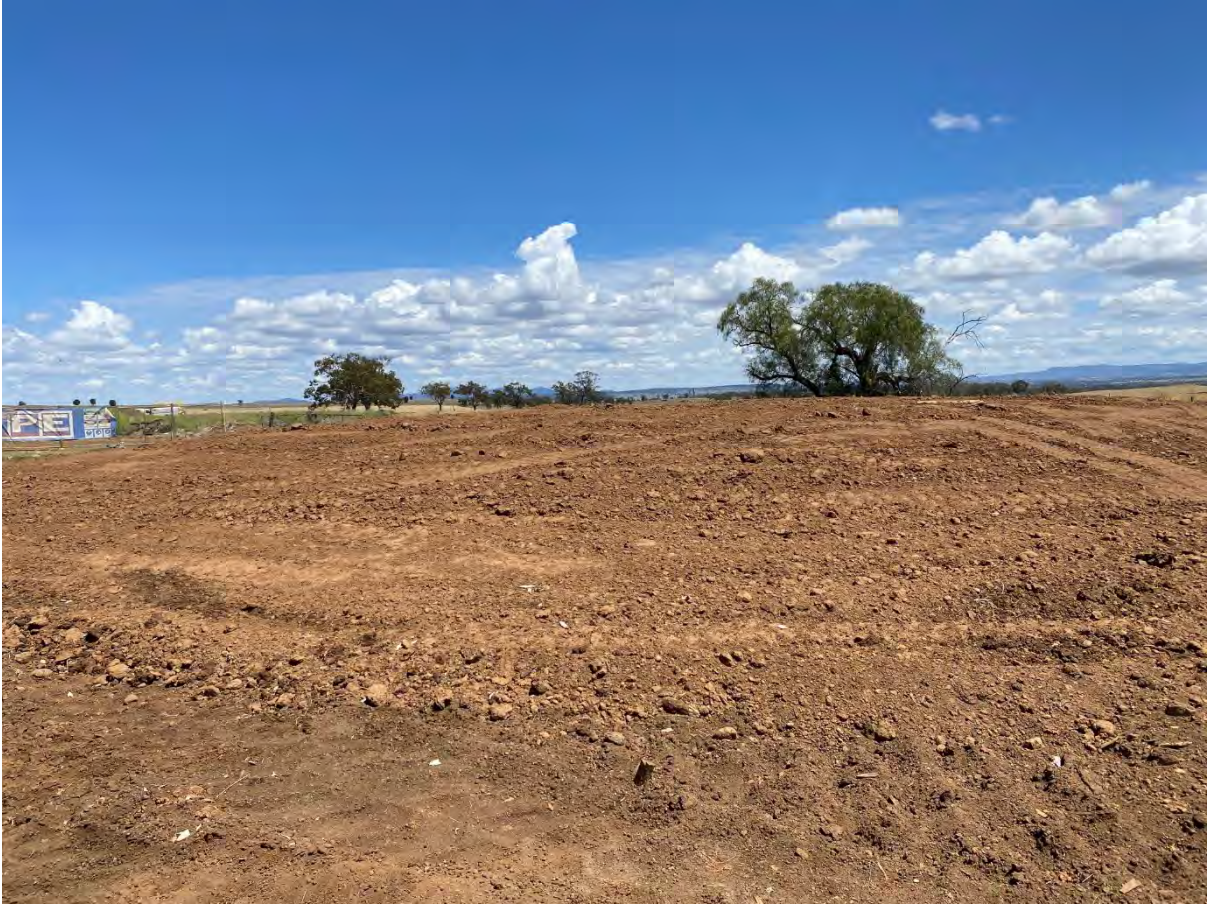
Plate 2 looking across the CAP towards the east from the west

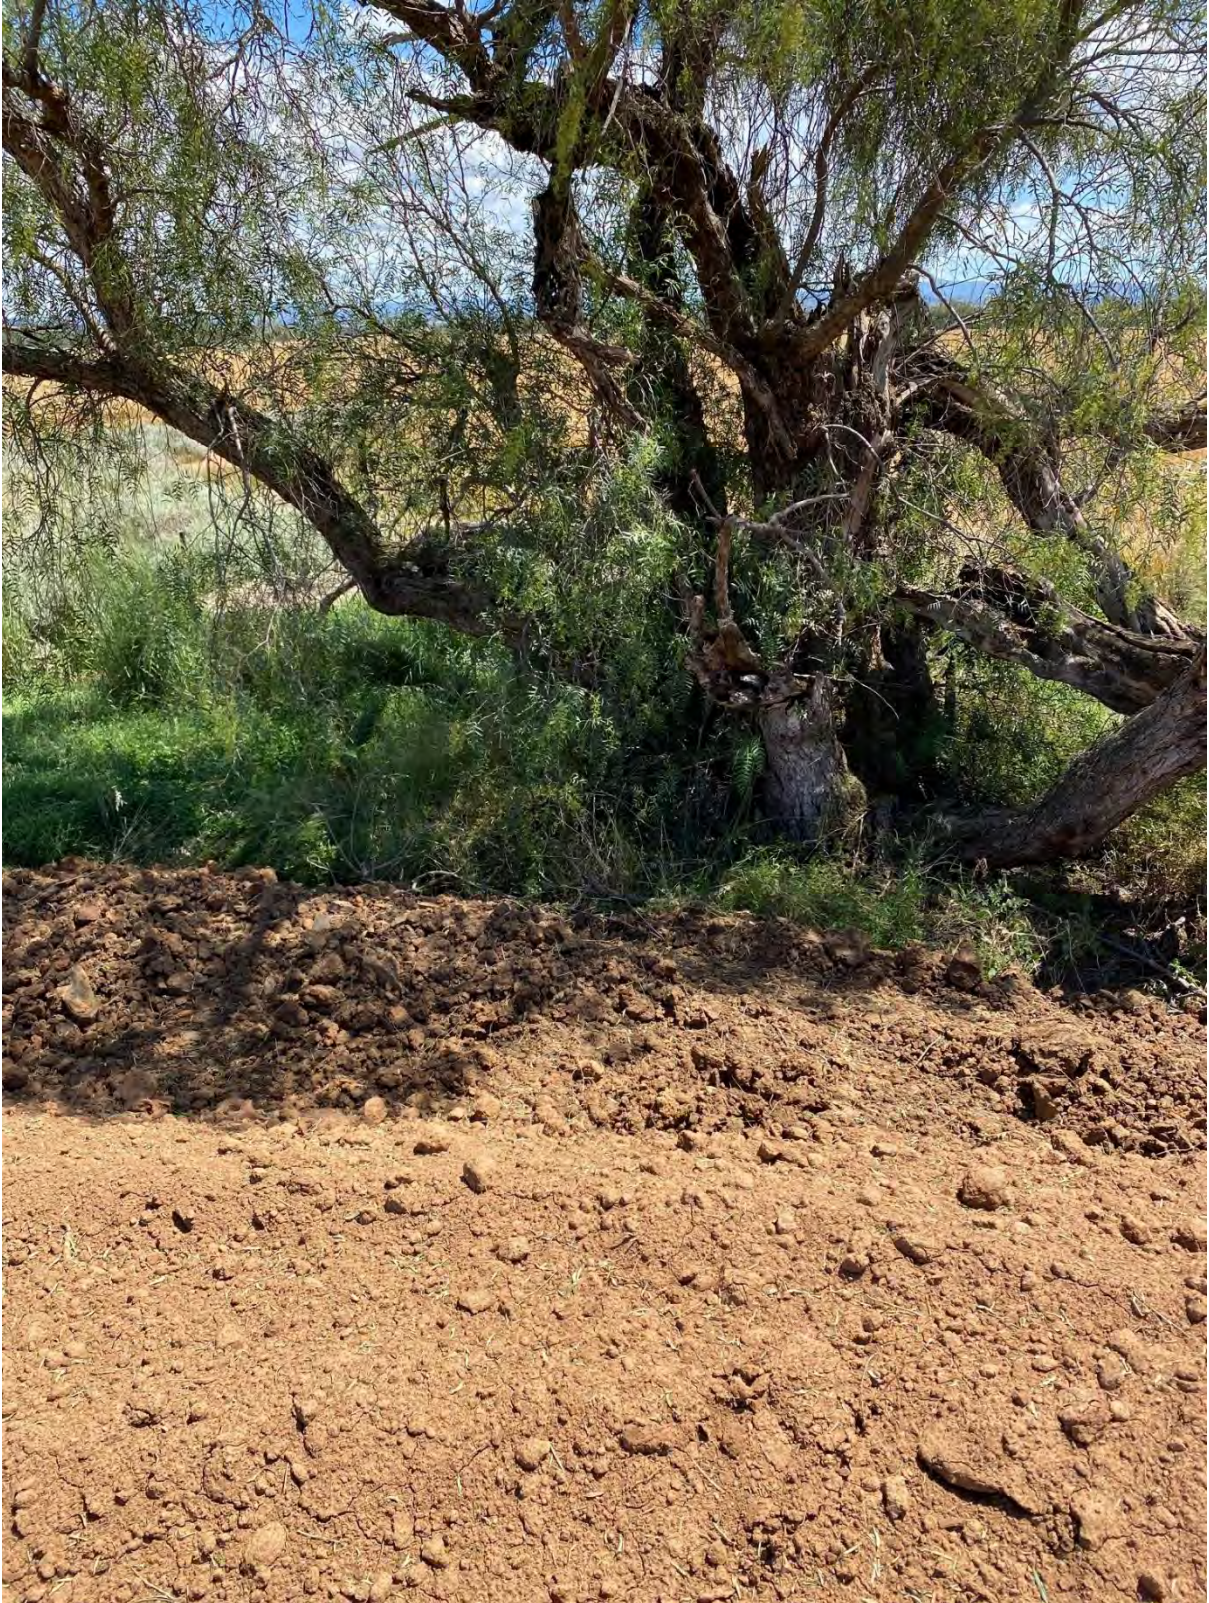
The Auditor was informed by SLR that that the position of TP203 was beneath the CAP extent.

Plate 3 at the indicative position of TP203 looking north east whilst standing on the CAP

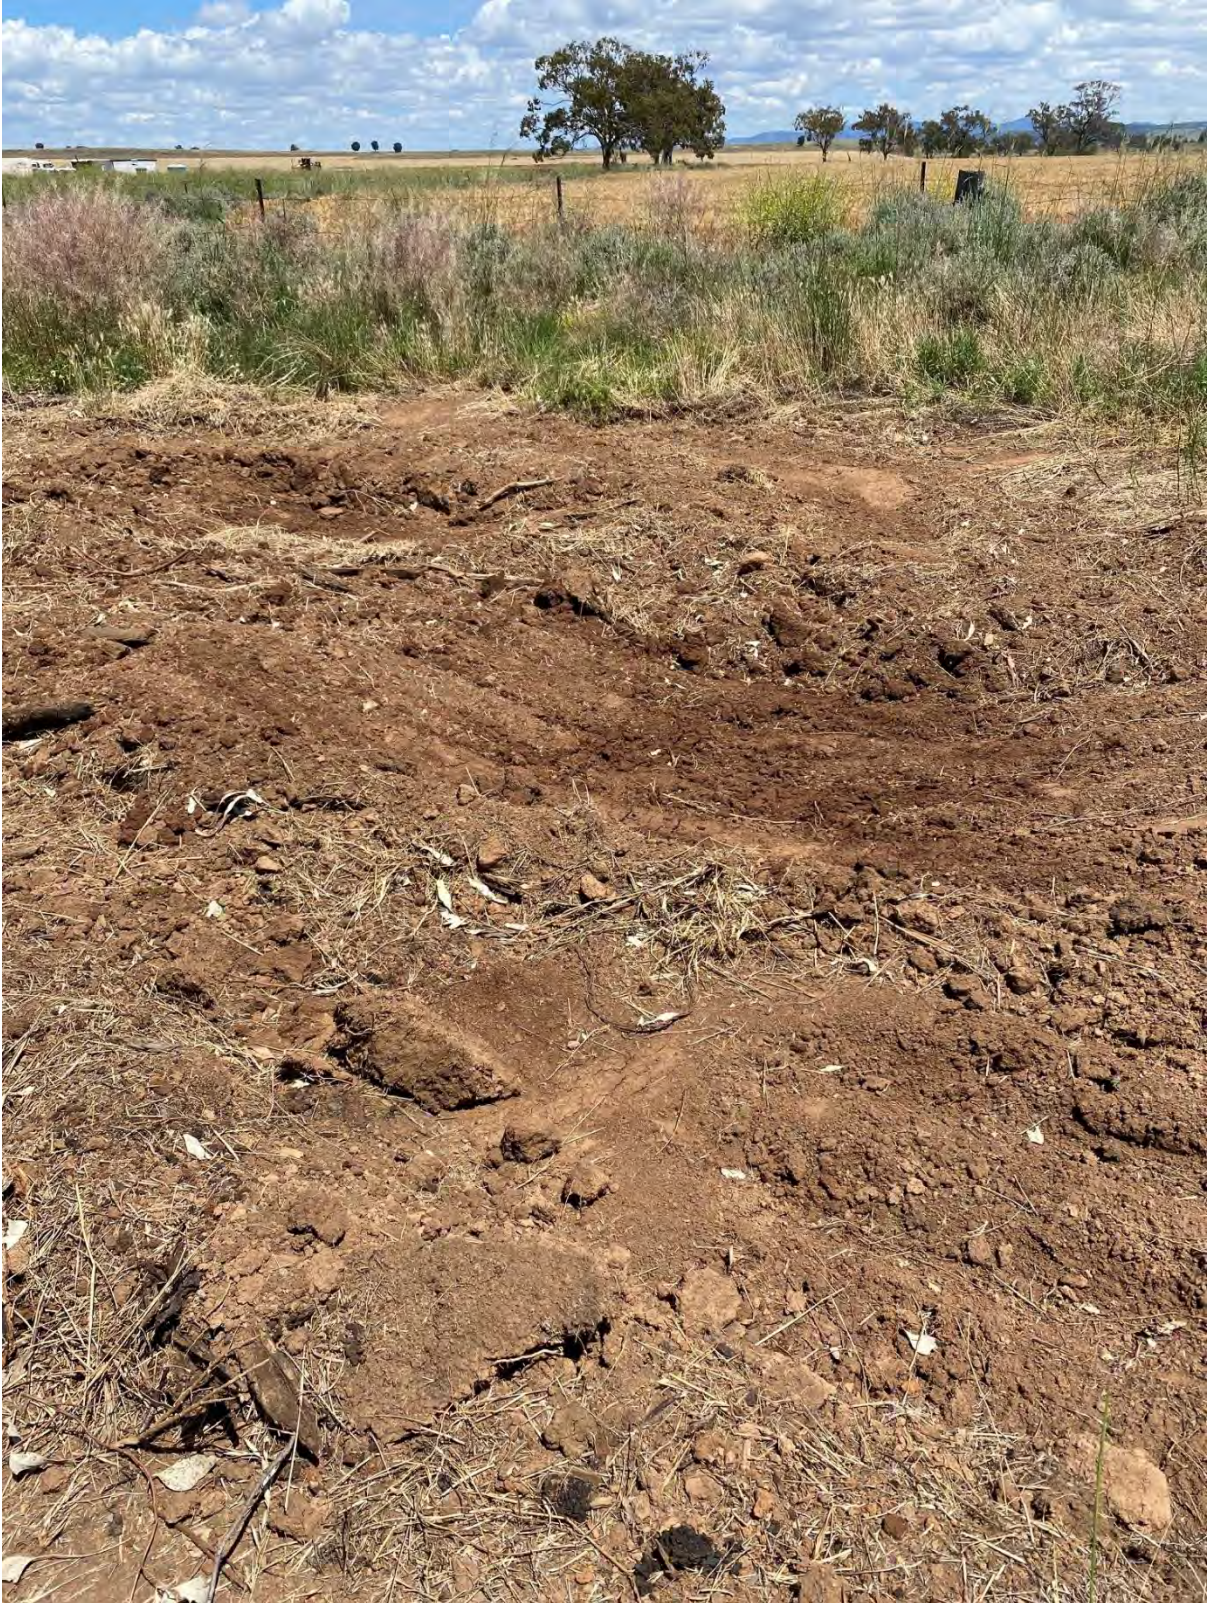
Plate 4 standing on the CAP extent looking at the unknown excavation noted verbally to be from tree removal.

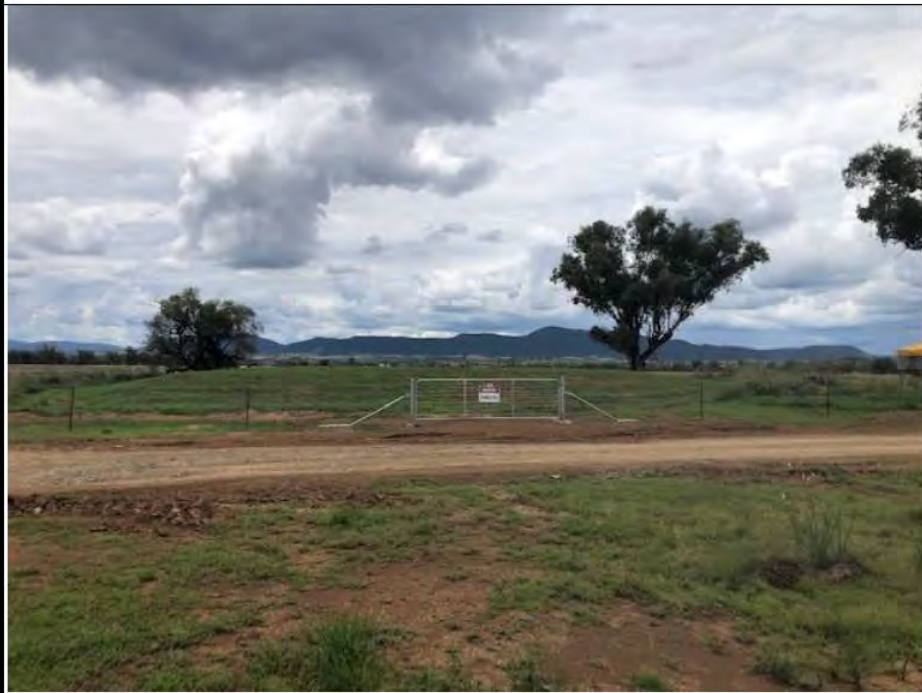
Photograph 37 – Capping area showing fencing and revegetation

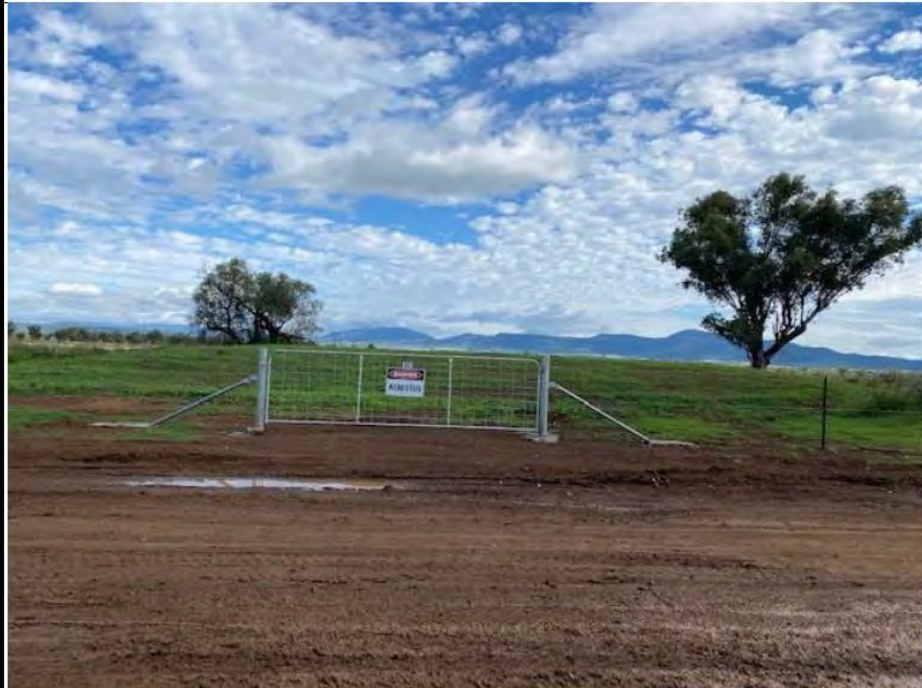
Photograph 38 - Capping area showing fencing with asbestos signage and revegetation

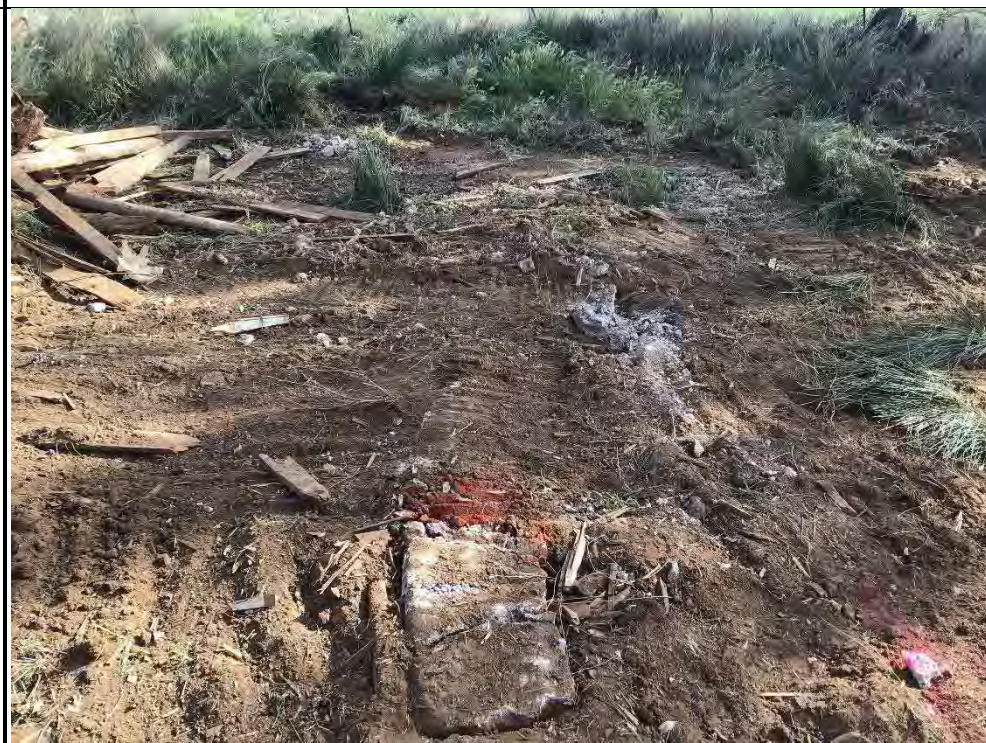
Photograph 1 – Remnants of former sheep dip, facing north towards TP205

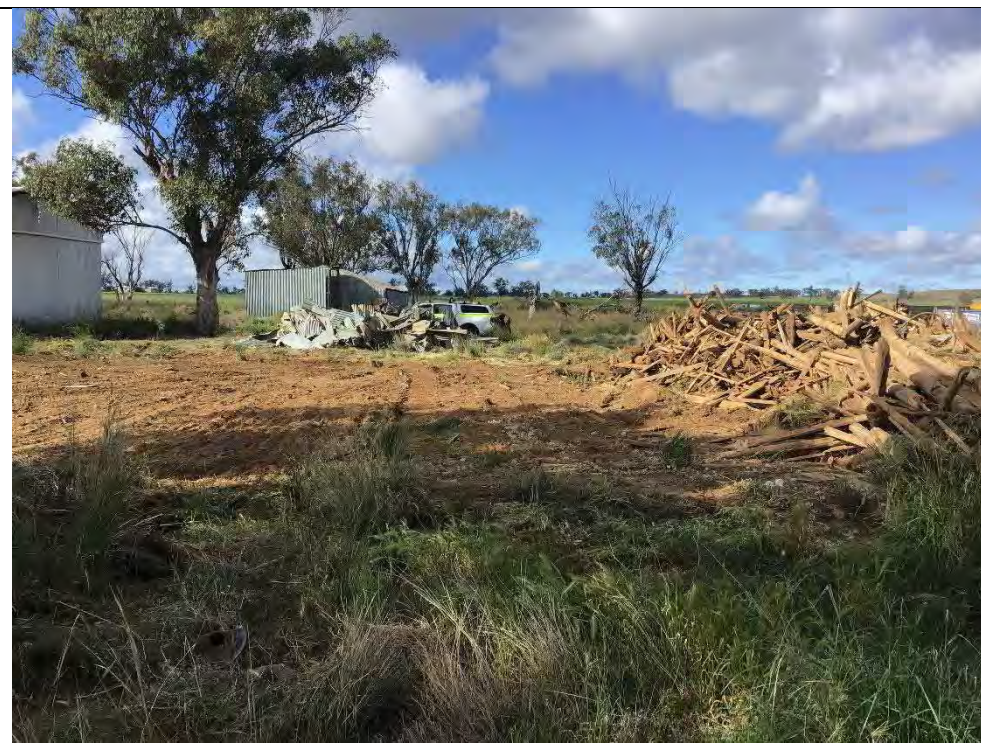
Photograph 3 – Capping area prior to remediation facing south from TP205, showing stockpiled timber from former sheep shed

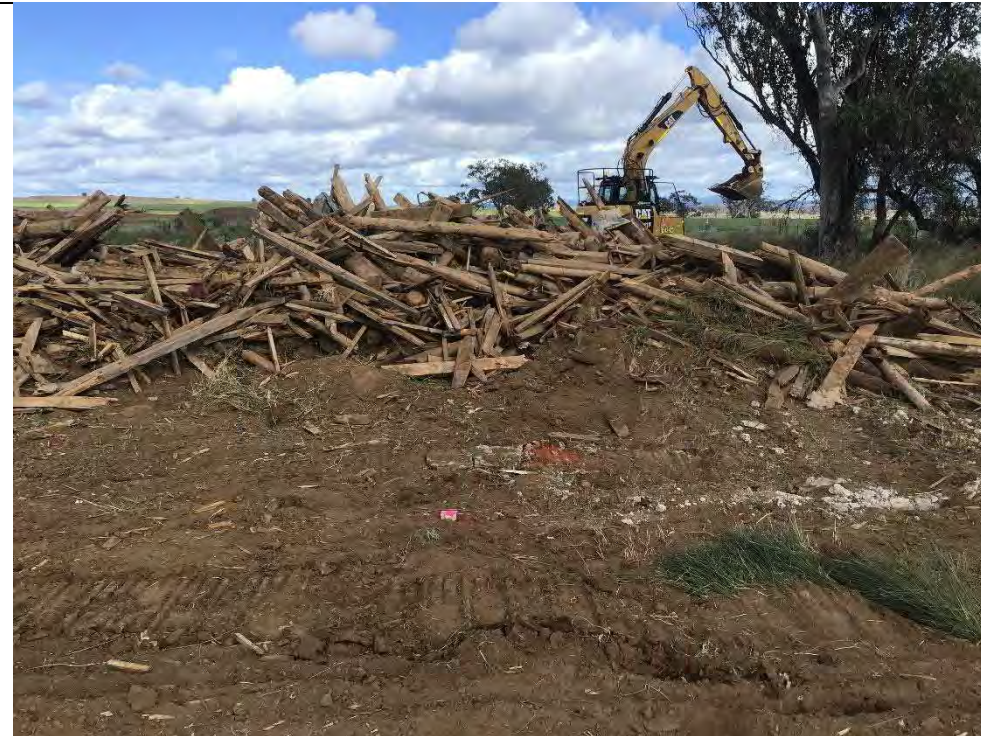
Photograph 4 – Timber stockpile from sheep holding shed demolition, facing west from TP102

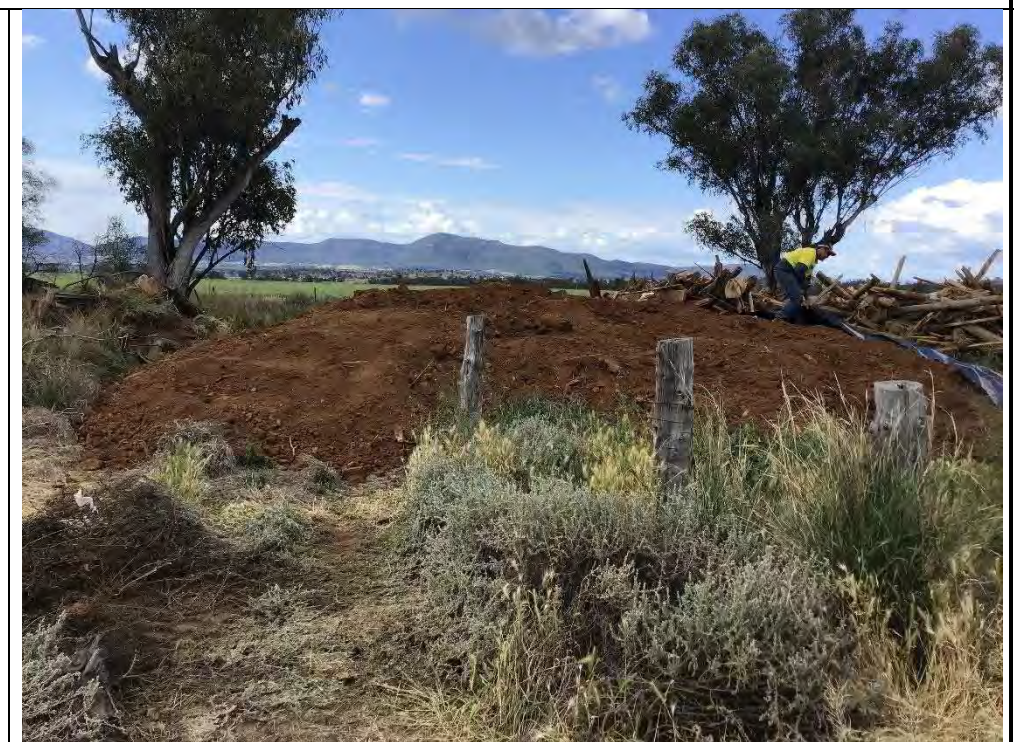
Photograph 11 – Stockpiled material from unexpected finds, facing north

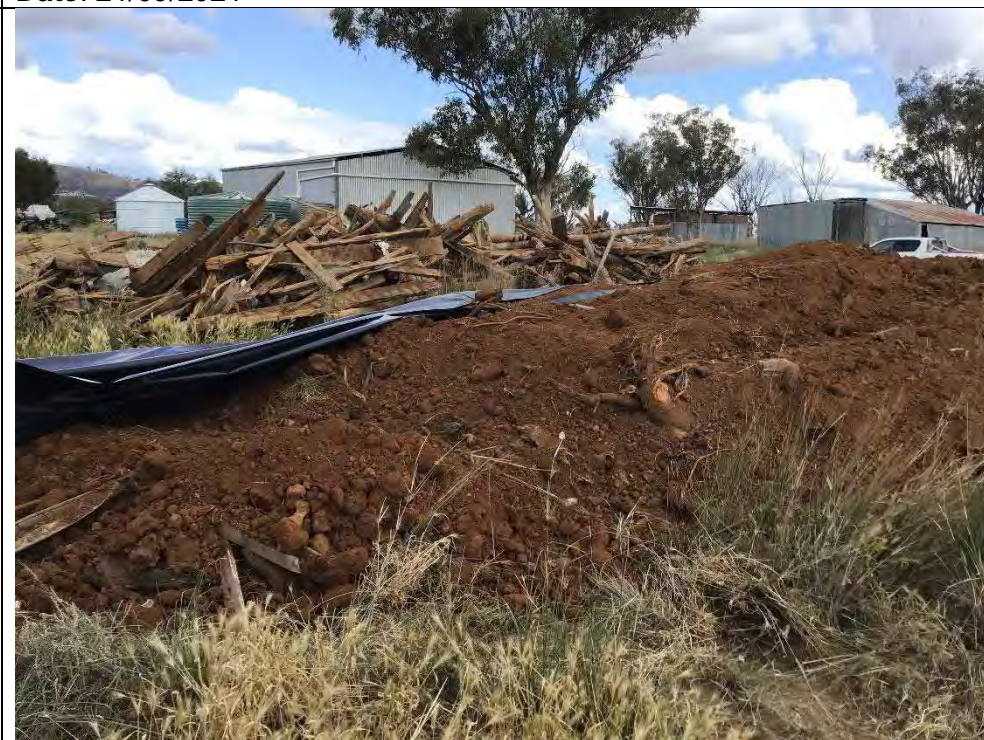
Photograph 10 – Stockpiled material from unexpected finds, facing east

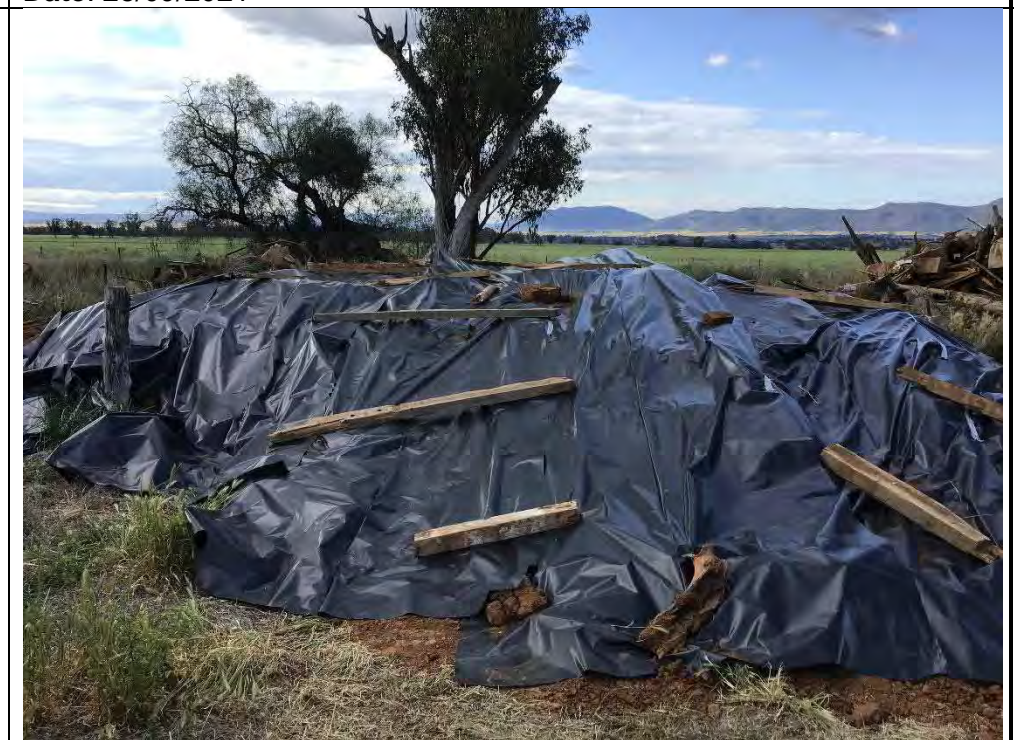
Photograph 12 – Covered stockpile of unexpected find material, facing north from between TP201 and TP202

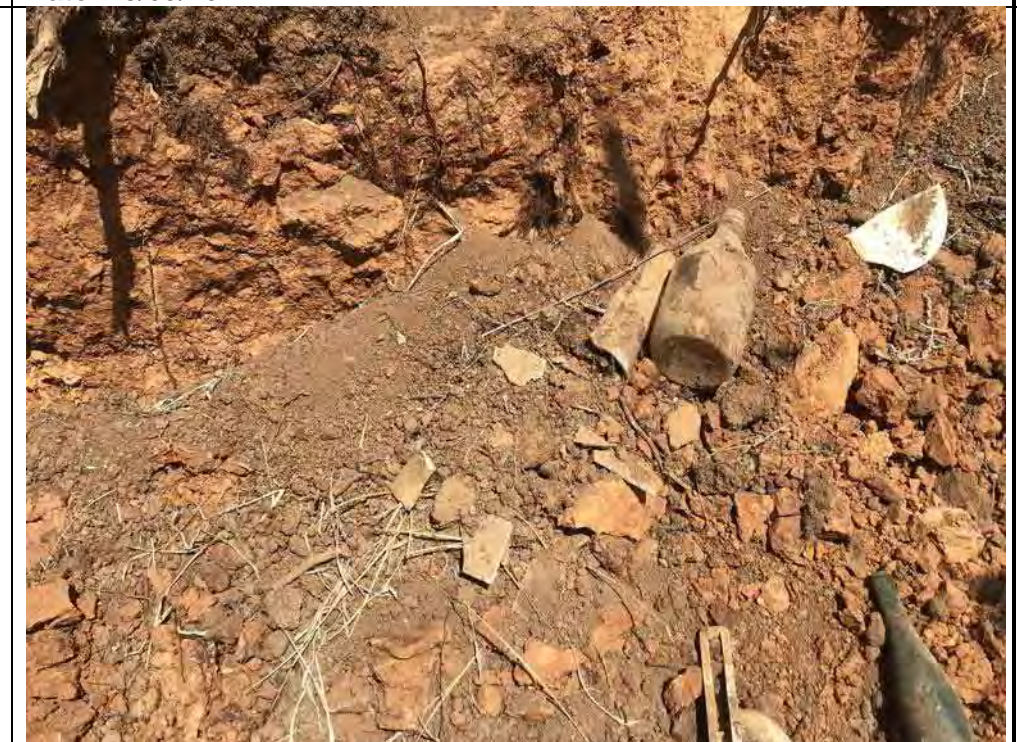
Photograph 18 – Example of anthropogenic material including ACM

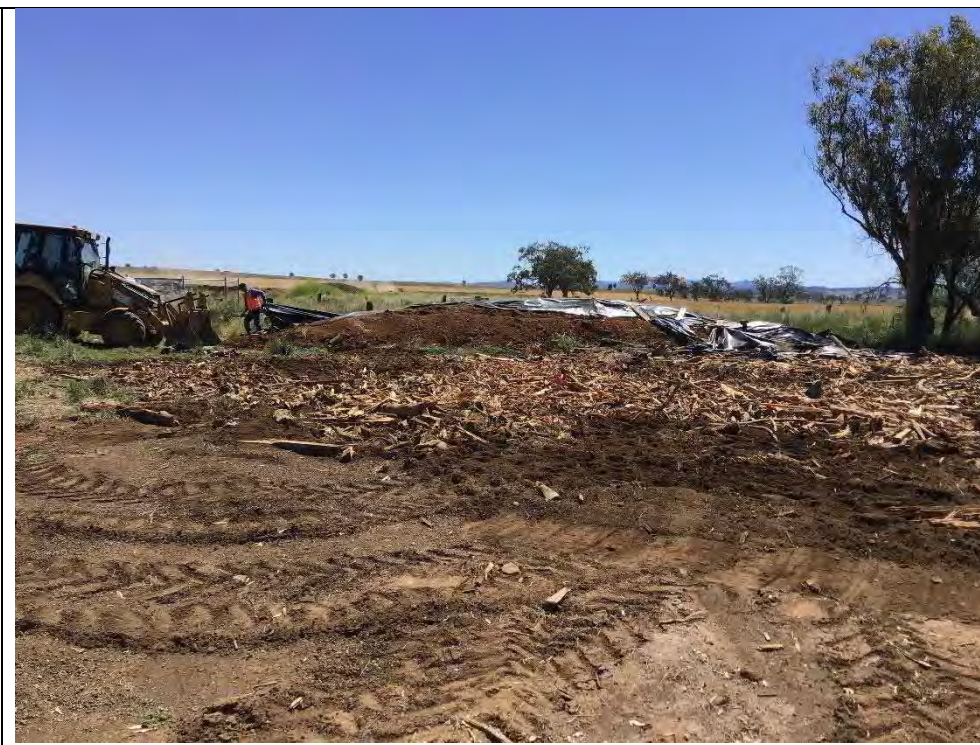
Photograph 21 – Timber stockpile spread and compacted into surface within the remediation area, from adjacent TP 103

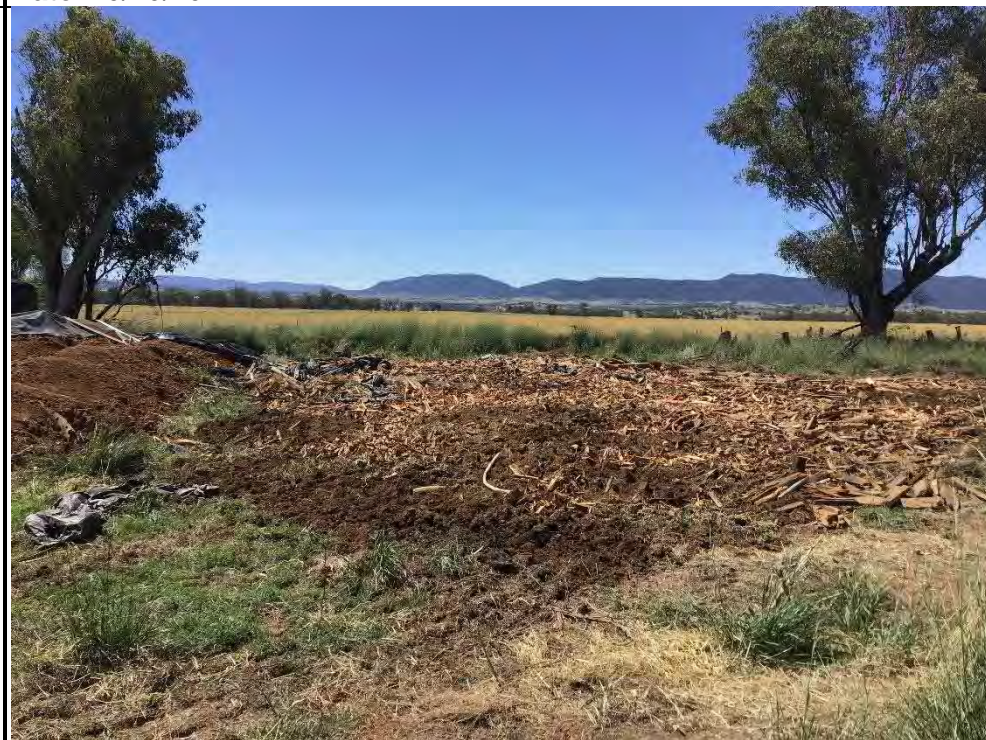
Photograph 20 – Timber stockpile spread and compacted into surface within the remediation area, facing north from TP 201

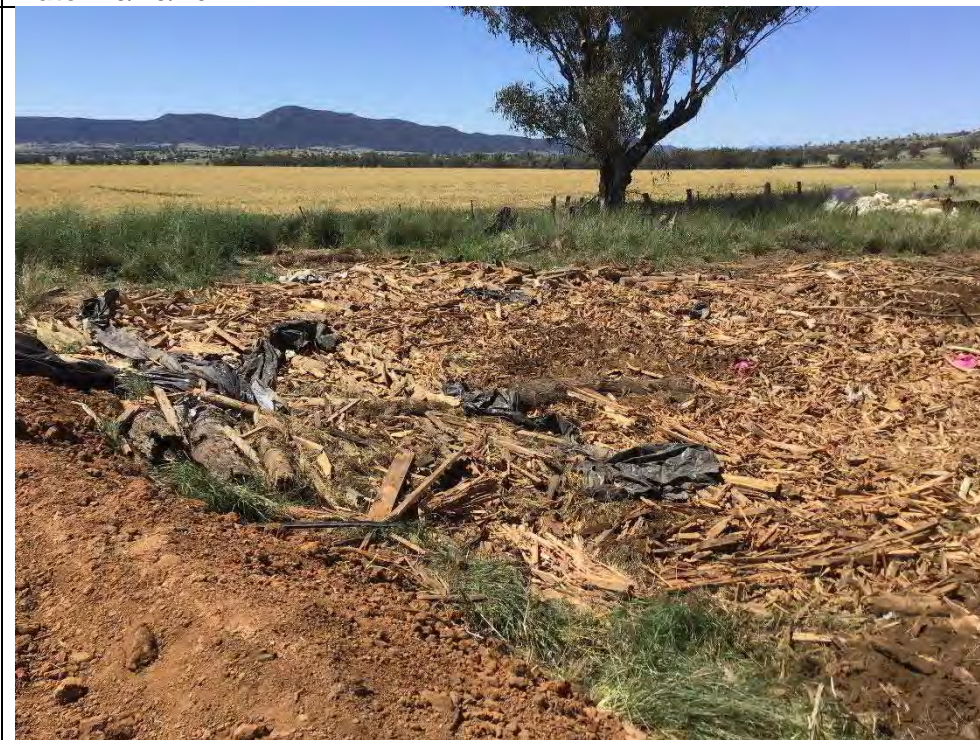
Photograph 22 – Timber stockpile spread and compacted into surface within the remediation area, facing north from adjacent TP202
