HENDERSON POULTRY PRODUCTION FARM

Drainage and Nutrient Management Plan

Prepared for:
ProTen Limited

SLR Ref: 675.30036.00000-R02
Version No: v1.0
June 2021

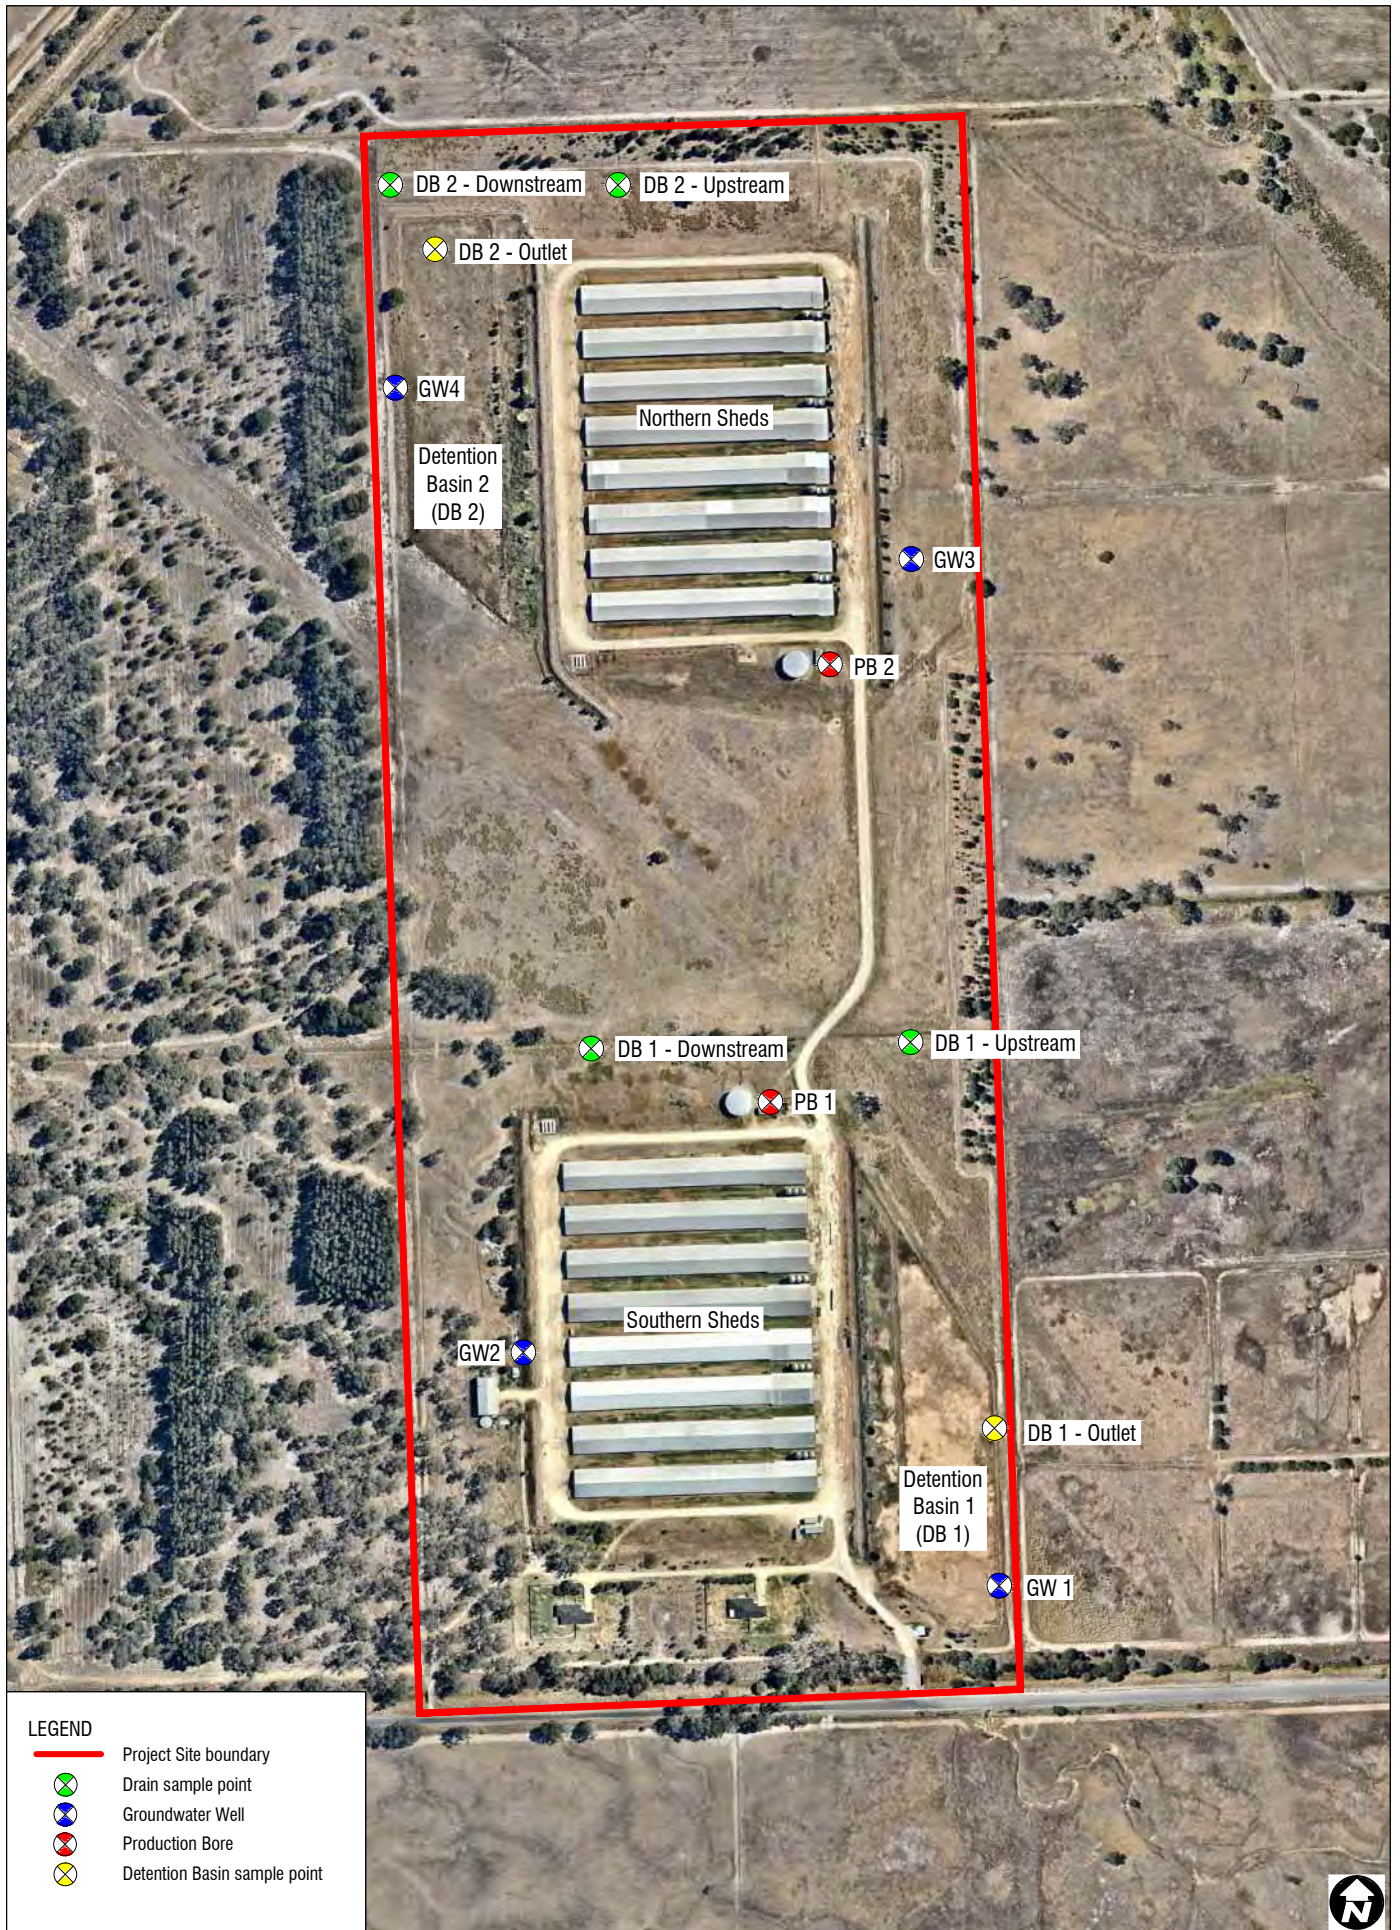
The sampling locations are presented in Figure 4.

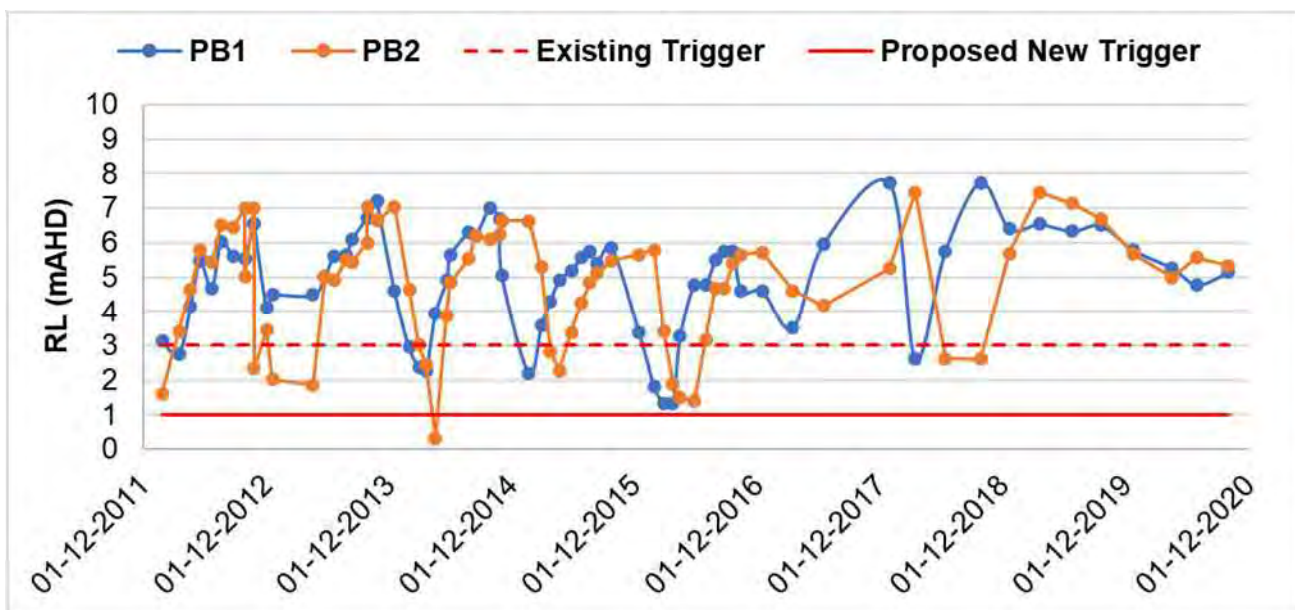
Figure 5 Groundwater levels at PB1 and PB2 in mAHD

Table 7 contains updated triggers levels for groundwater levels and groundwater quality at which the implementation of contingency actions would be considered. On recommendation from DWER, the groundwater level trigger for PB1 and PB2 was reviewed and revised. Water levels in the production bores have historically ranged between 1 m AHD and 8 m AHD, and no decreasing trend in water level is observed (Figure 5). As such, the 3 m AHD trigger, which has been breached each year, is not an appropriate trigger level. Therefore, as recommended by DWER, the trigger level is amended to 1 m AHD. Similarly, water level at GW01 and GW02 have historically ranged from 15 m AHD to 18 m AHD. As such, the water level trigger for GW01 and GW02 has been set at 15 m AHD. The water level readings must be taken at least 8 hours after cessation of pumping to avoid pump influence causing non-representative groundwater level trigger exceedance.

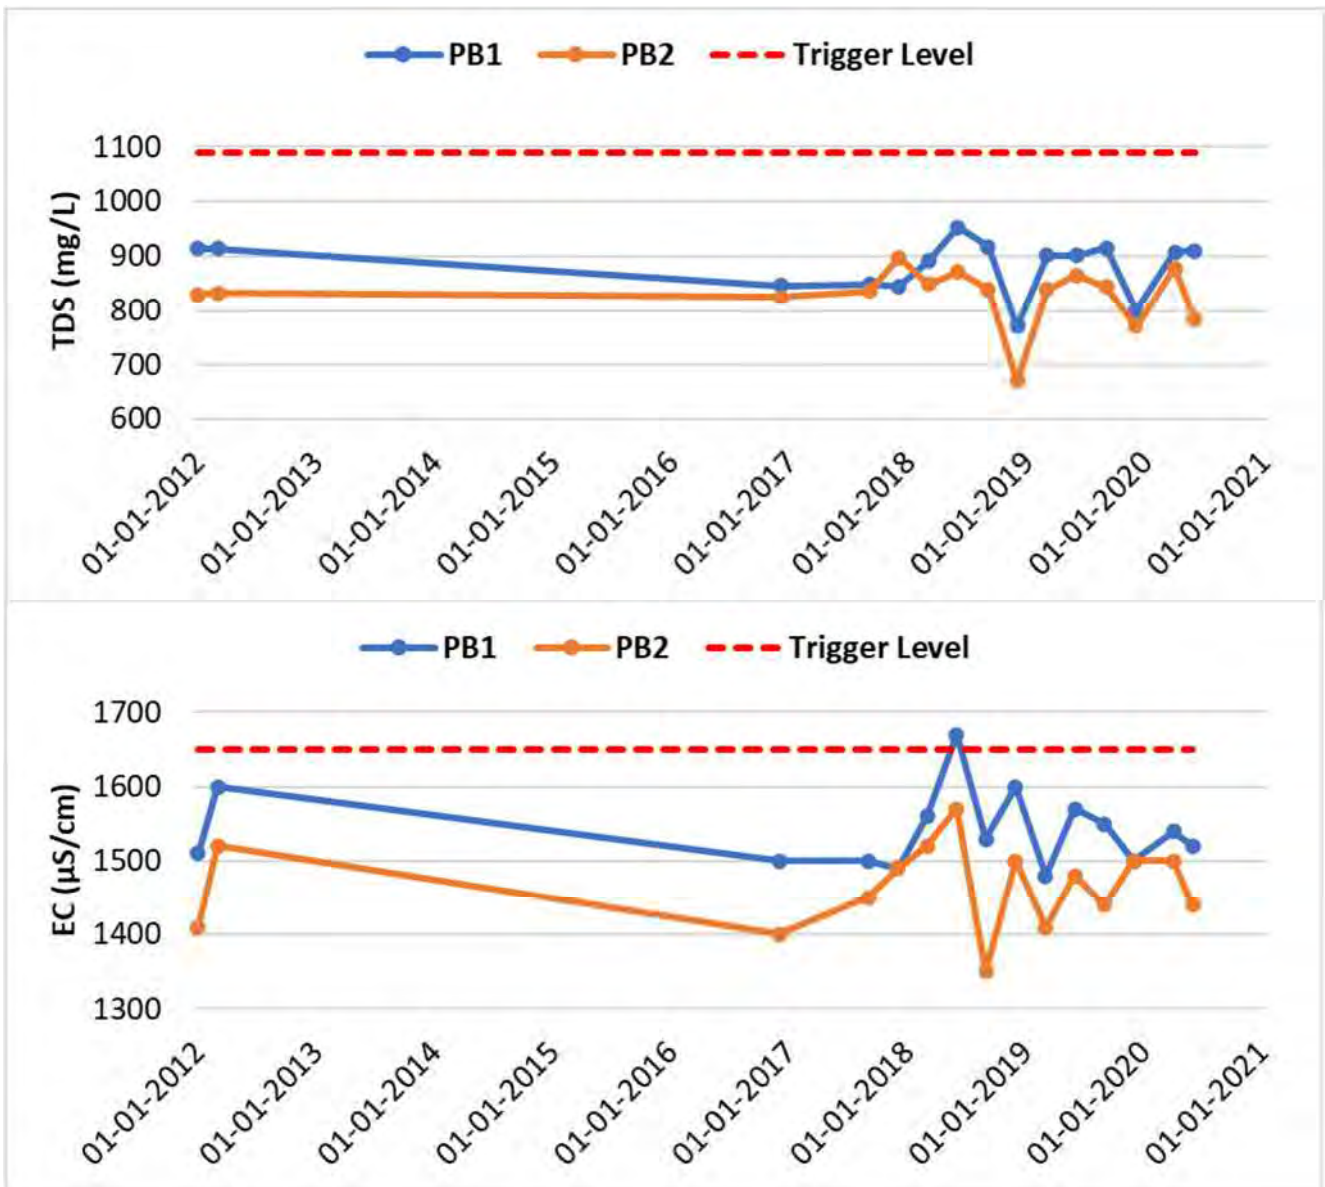
Figure 6 EC and TDS at PB1 and PB2 along with the Current Trigger

DWER also recommended reviewing the trigger levels for EC and TDS. On reviewing it was observed that the changes in the EC and TDS are within historical range and the current trigger levels are appropriate and suitable (Figure 6).
