Rushes Creek Poultry Production Farm

Fire Safety Study

Project Number: 12545704

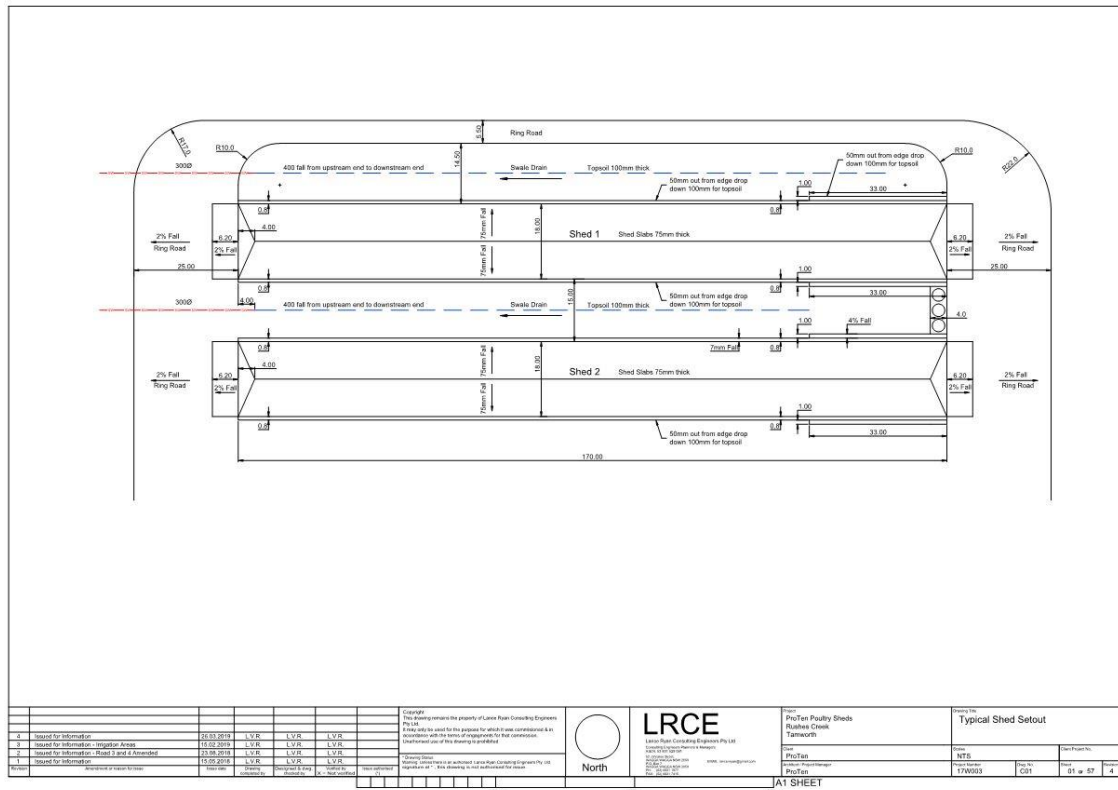
Figure 3: Typical shed layout (Lance Ryan Consulting Engineers Pty Ltd, 2019)

Based on the civil drawings set, issued by Lance Ryan Consulting Engineers Pty Ltd on 26 March 2019, Rev 4, the individual sheds will measure approximately 160 m in length and 18.0 m wide, equating to a footprint of approximately 2,880 m². They are understood to measure approximately 4.7 m to the ridge of the roof and 2.6 m under the eaves.

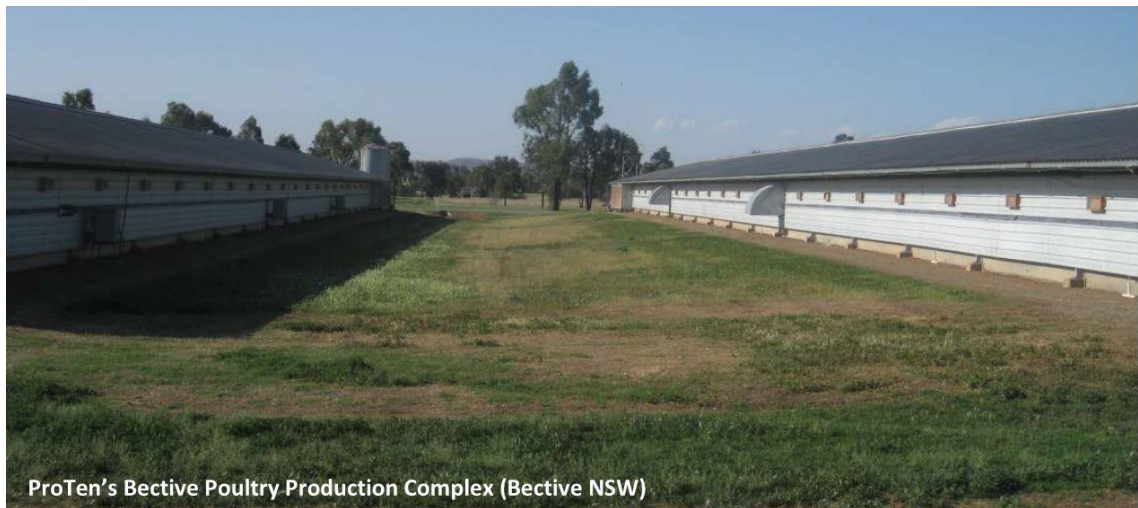
Figure 4: ProTen's Bective Poultry Production Complex (SLR, 2018)

The floor bedding material is understood to consist of soft wood shavings, rice hulls or chopped straw. The flooring will be raw cured concrete and surrounded by a 0.4 m high dwarf concrete bund. All expansion gaps and saw cuts are understood to be Sikaflex filled. An image from one of ProTen’s existing sites (Bective Poultry Production Complex) which is built to a similar specification is shown for reference in Figure 4.

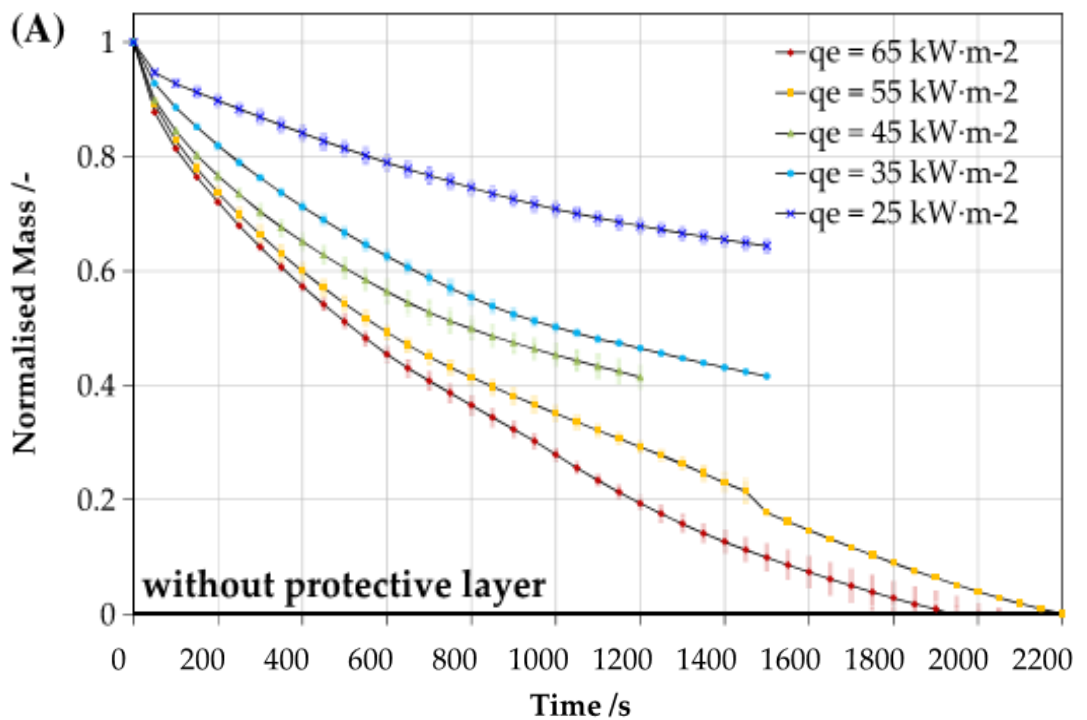
Figure 12: Normalised mass of PIR over time (Juan P.Hiadlgo, 2017)

It is further noted that under irradiance exposure levels above 55 kW/m², the PIR was consumed by the end of the experiment. Under lower levels of exposure, this was not the case. Refer Figure 12 illustrating normalised mass of PIR over time (Juan P.Hiadlgo, 2017).

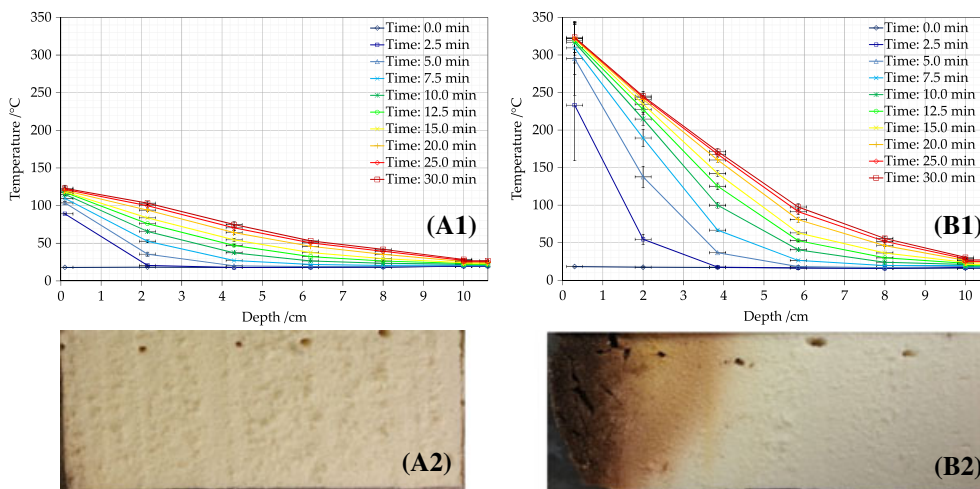
FIGURE 8 In-depth thermal profiles of PIRa at 10 kW/m^2 A1, with and B1, without protective layer. Centre section for the end of the tests A2 and B2. Horizontal error bars: estimated error of $\pm 2 \text{ mm}$ in thermocouple positioning. Vertical error bars: standard deviation between 2 repeated tests. PIR, polyisocyanurate [Colour figure can be viewed at wileyonlinelibrary.com]

Figure 8B presents a case study where thermal degradation was observed at the surface of the sample. Thermal gradients were significantly larger than those shown in Figure 8A1, indicating the clear effect of the protective layer on the thermal performance. Positions close to the surface achieved a quasi-steady temperature after 5 minutes, with a maximum value of 323°C ± 20°C, while the temperature profile again achieved a quasi-steady state after 20 minutes, with a minimal rate of temperature increase (<1°C/min) for inner

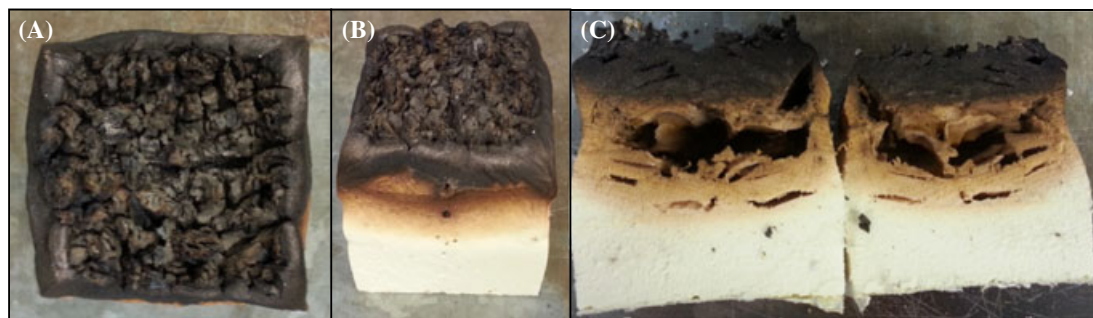
FIGURE 10 PIRa sample residue at 25 kW/m² without protective layer up to 22.5 minutes A, top view, B, lateral view, and C, lateral view from section. PIR, polyisocyanurate [Colour figure can be viewed at wileyonlinelibrary.com]

Figure 10 shows the sample residue from different perspectives for the test presented in Figure 9B (25 kW/m^2 without protective layer for 22.5 min). The surface of the sample presents complex morphology characterised by craters formed by surface oxidation. It can be observed that the char at the edges and lateral sides of the sample presents a smooth morphology, indicating that oxidation did not take place. This is consistent with the set-up that uses aluminium foil to prevent air penetration through the sides, thus limiting oxidation to the top surface.

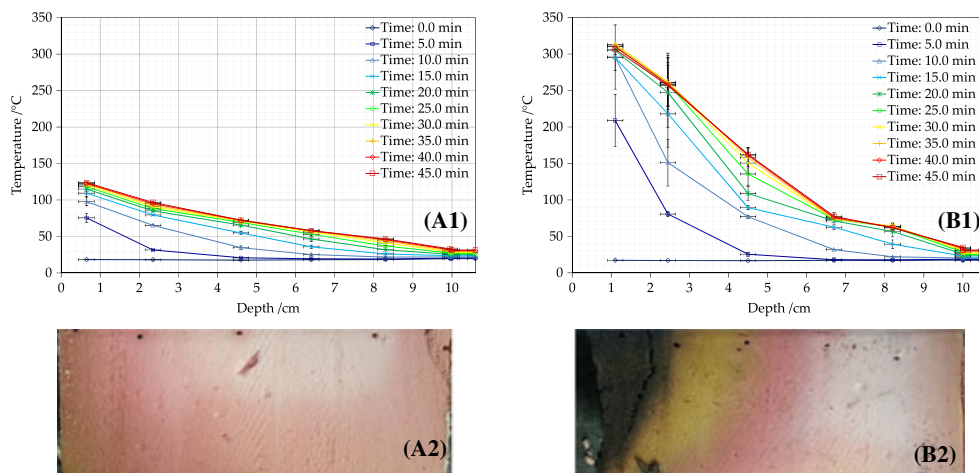
FIGURE 14 In-depth thermal profiles of PF at 10 kW/m^2 with A1, and without protective layer B1. Centre section for the end of the tests A2 and B2. Horizontal error bars: estimated error of $\pm 2 \text{ mm}$ in thermocouple positioning. Vertical error bars: standard deviation between 2 repeated tests. PF, phenolic foam [Colour figure can be viewed at wileyonlinelibrary.com]

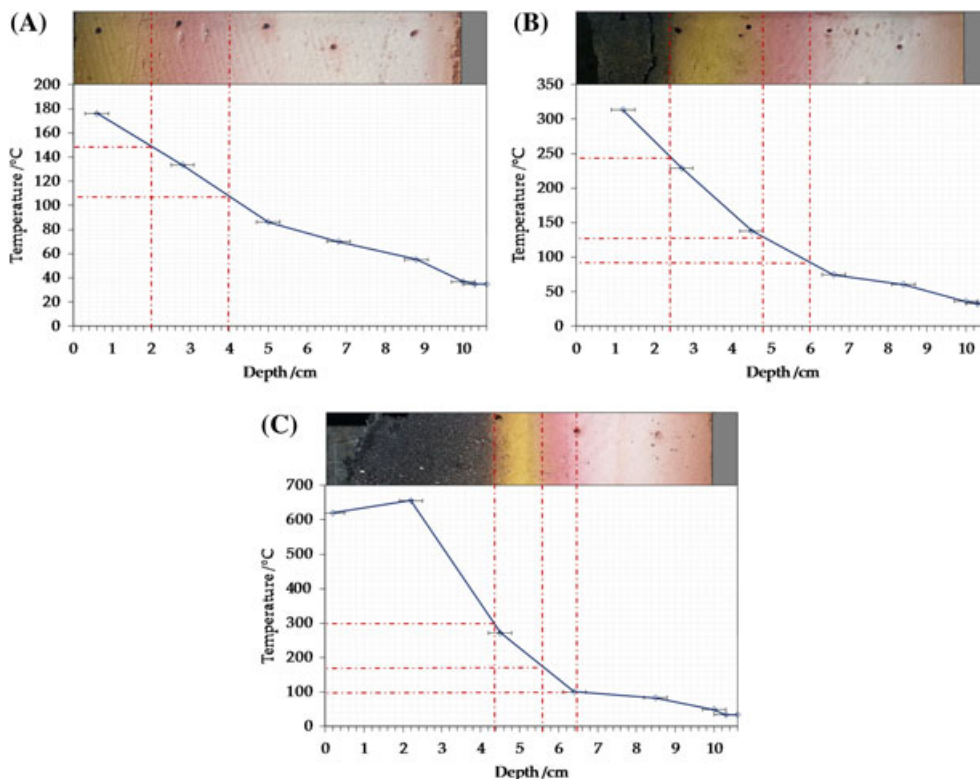
FIGURE 18 Maximum in-depth temperature profile of PF: A, 15 kW/m^2 (foil); B, 10 kW/m^2 (no foil); and C, 25 kW/m^2 (no foil). Horizontal error bars: estimated error of $\pm 2 \text{ mm}$ in thermocouple positioning. PF, phenolic foam [Colour figure can be viewed at wileyonlinelibrary.com]
