LONG TERM ENVIRONMENTAL MANAGEMENT PLAN

**Rushes Creek Poultry Production Farm
Rushes Creek Road, Rushes Creek, NSW**

ProTen Pty Ltd
North Sydney, NSW, 2060

SLR Ref: 610.30237.00000-R04
Version No: -v0.1
December 2021

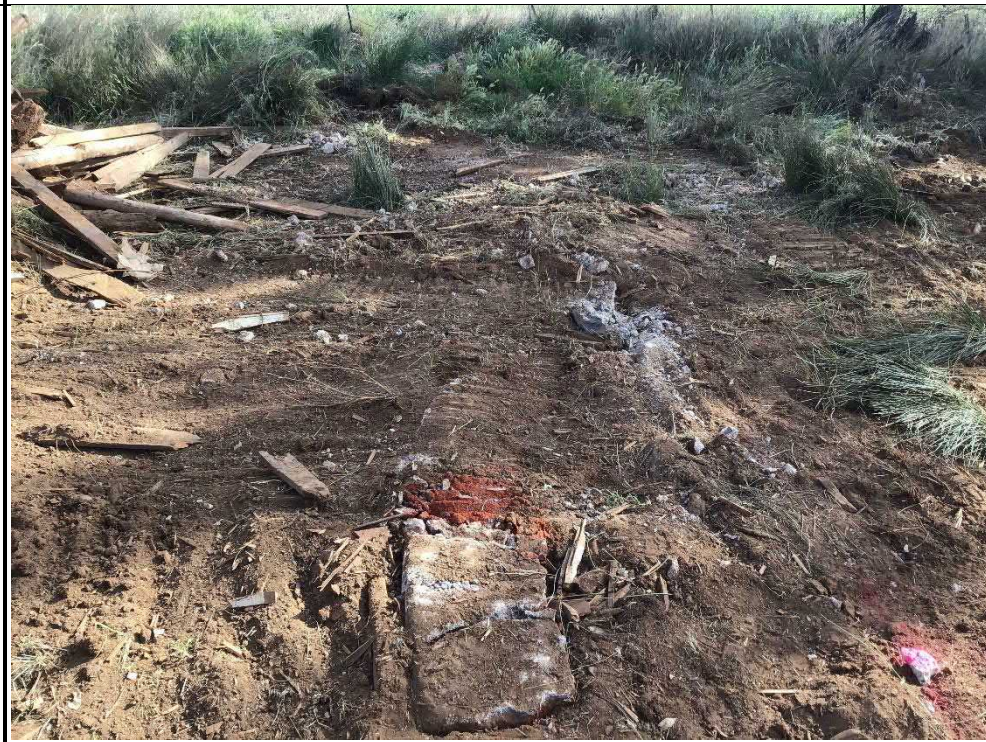
Photograph 1 – Remnants of former sheep dip, facing north towards TP205

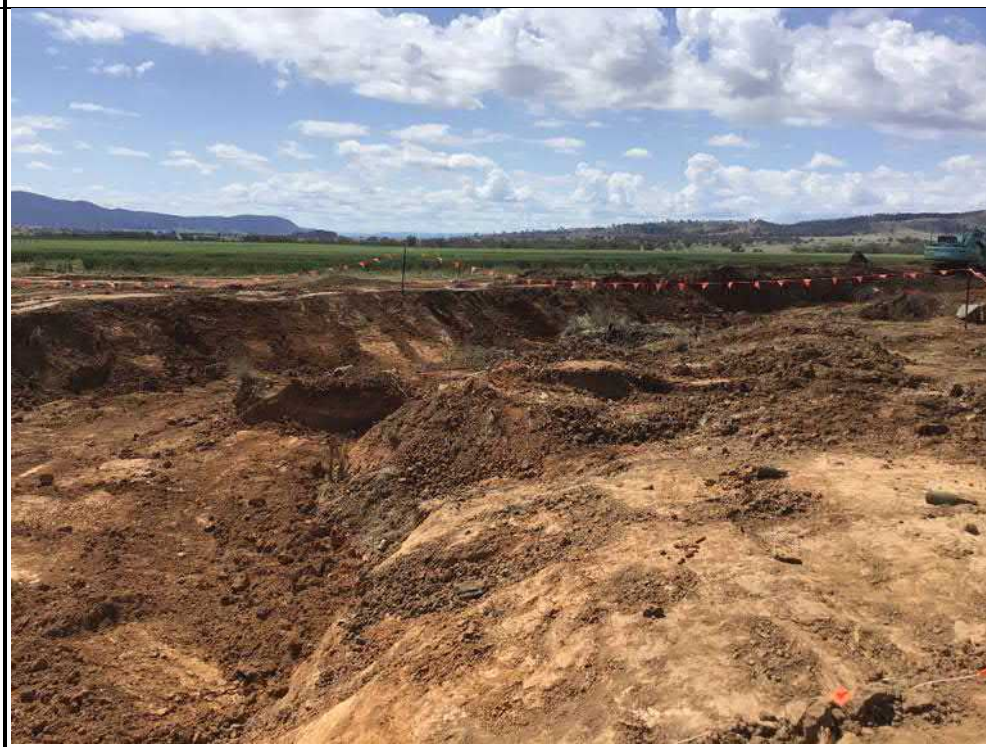
Photograph 13 – TP301 facing east, pre-excitation

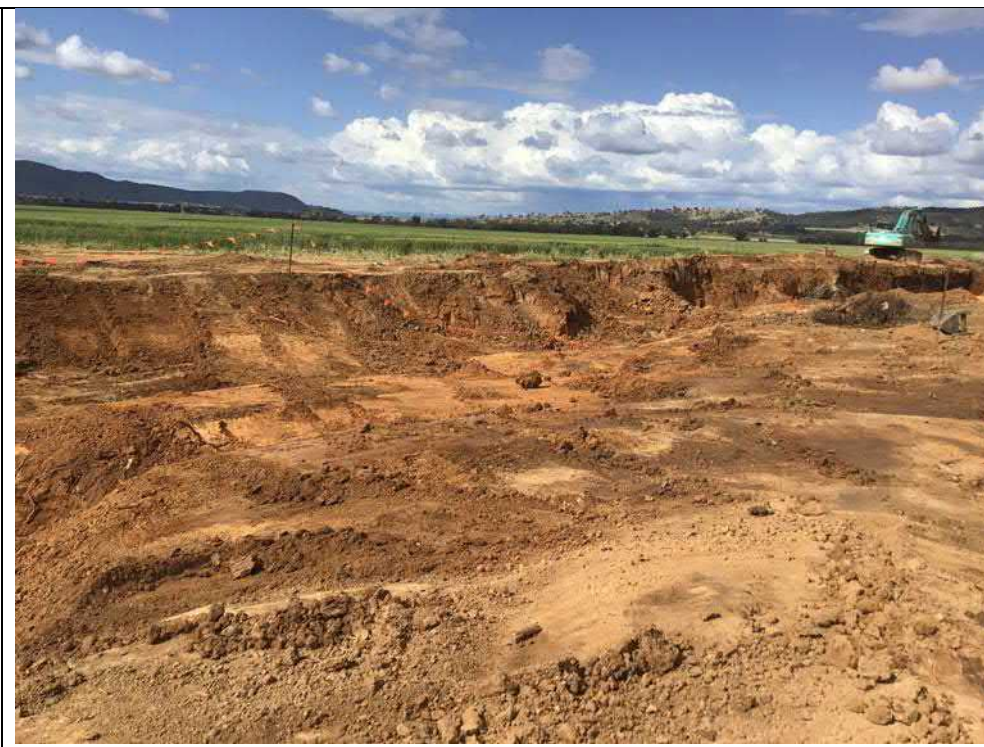
Photograph 15 – Adjacent TP301 facing east, post excavation

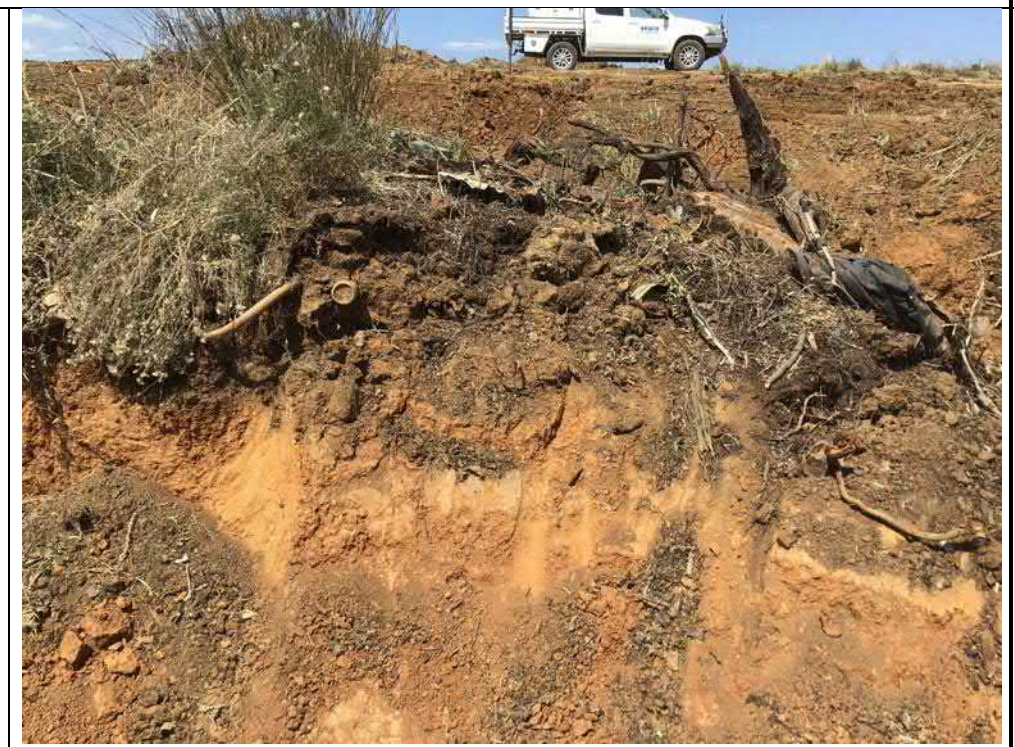
Photograph 17 – Example of soil profile

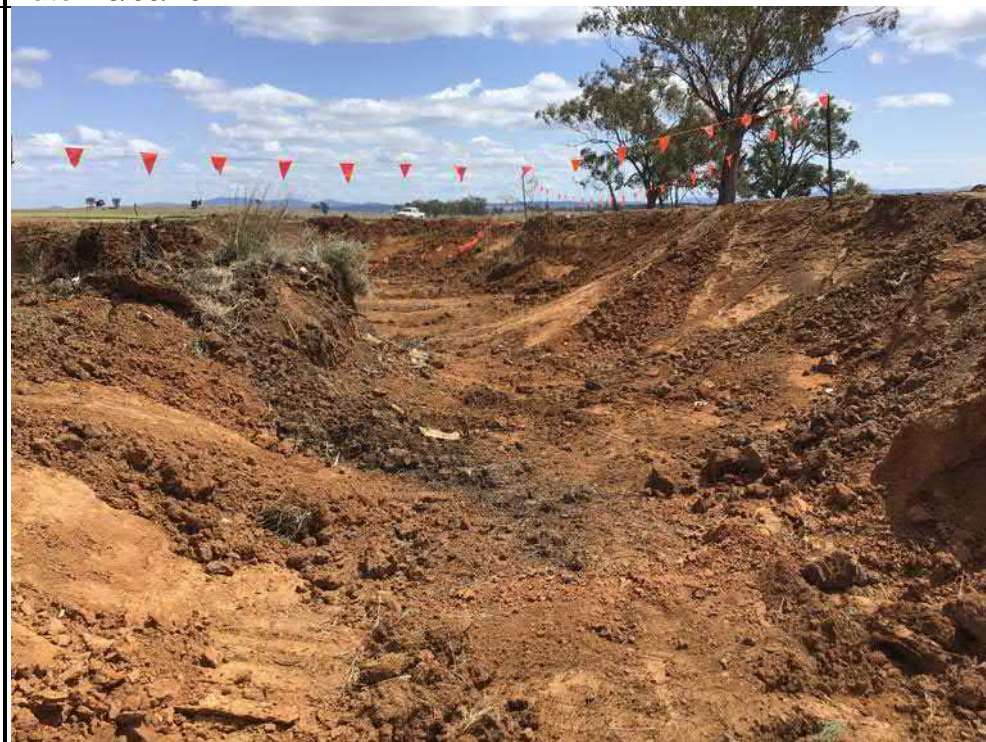
Photograph 14 TP303 Facing west, pre-excitation

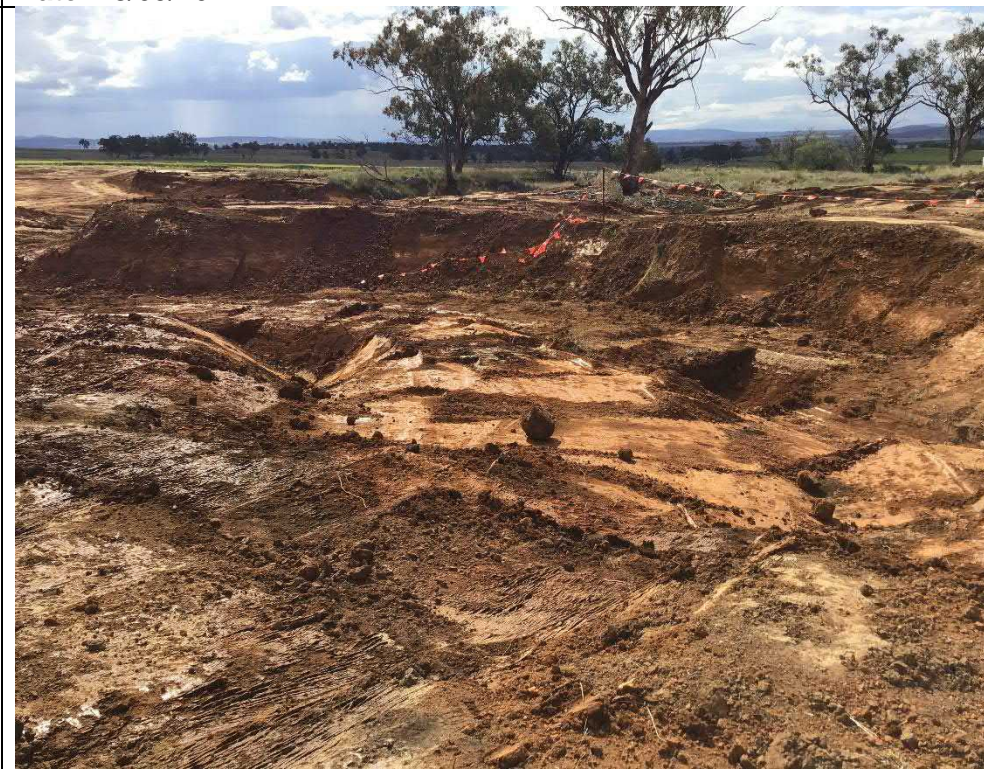
Photograph 16 – Adjacent TP303 facing west, post excavation

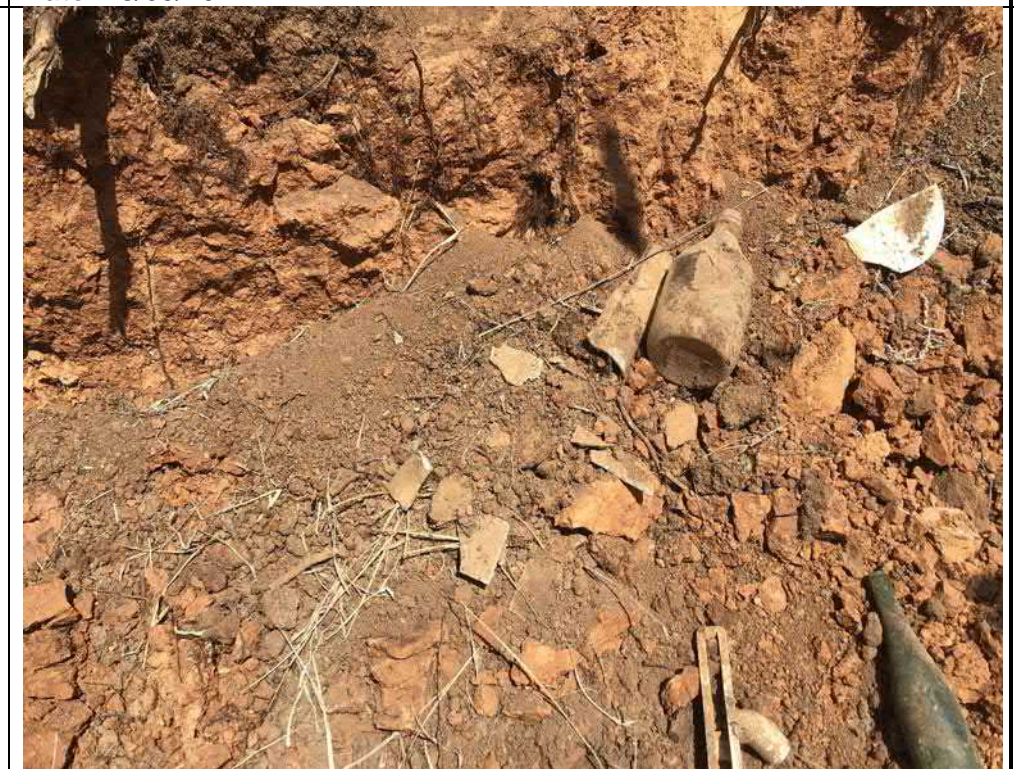
Photograph 18 – Example of anthropogenic material including ACM

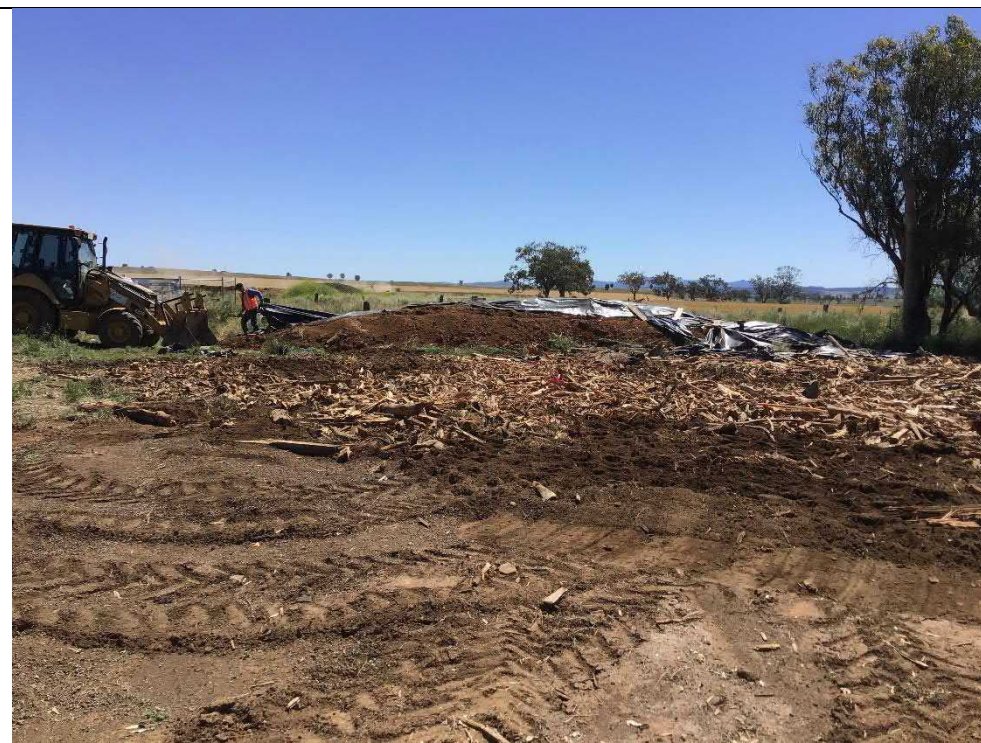
Photograph 21 – Timber stockpile spread and compacted into surface within the remediation area, from adjacent TP 103

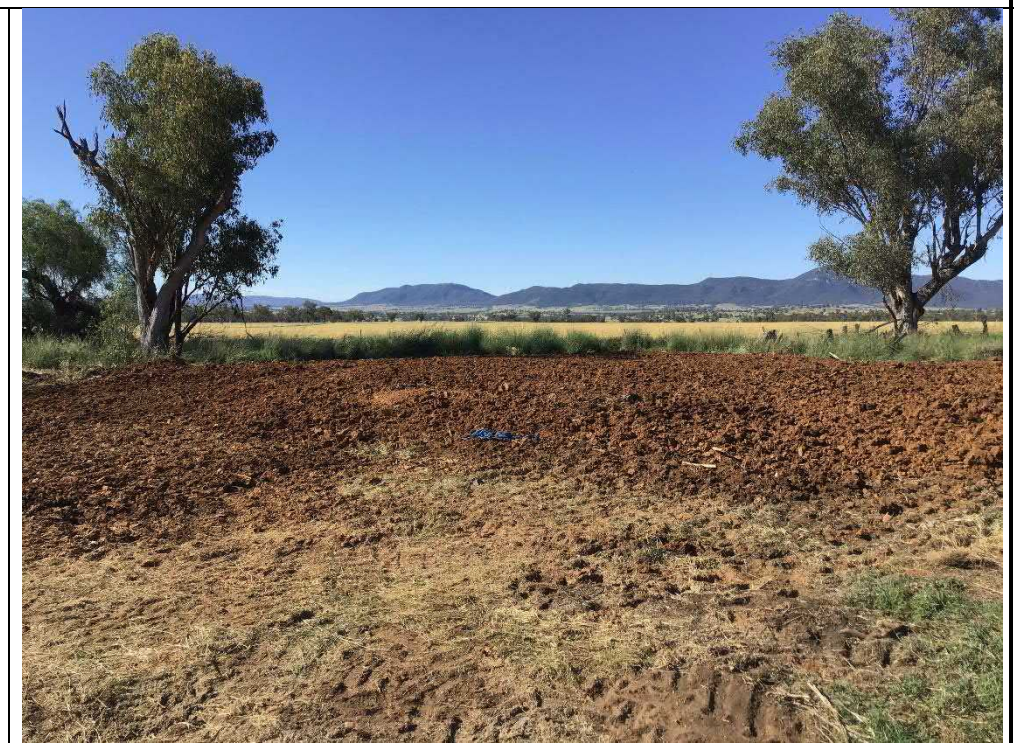
Photograph 23 – Unexpected finds stockpile spread within the remediation area to form part of the Earth Cover Layer of capping, from TP201

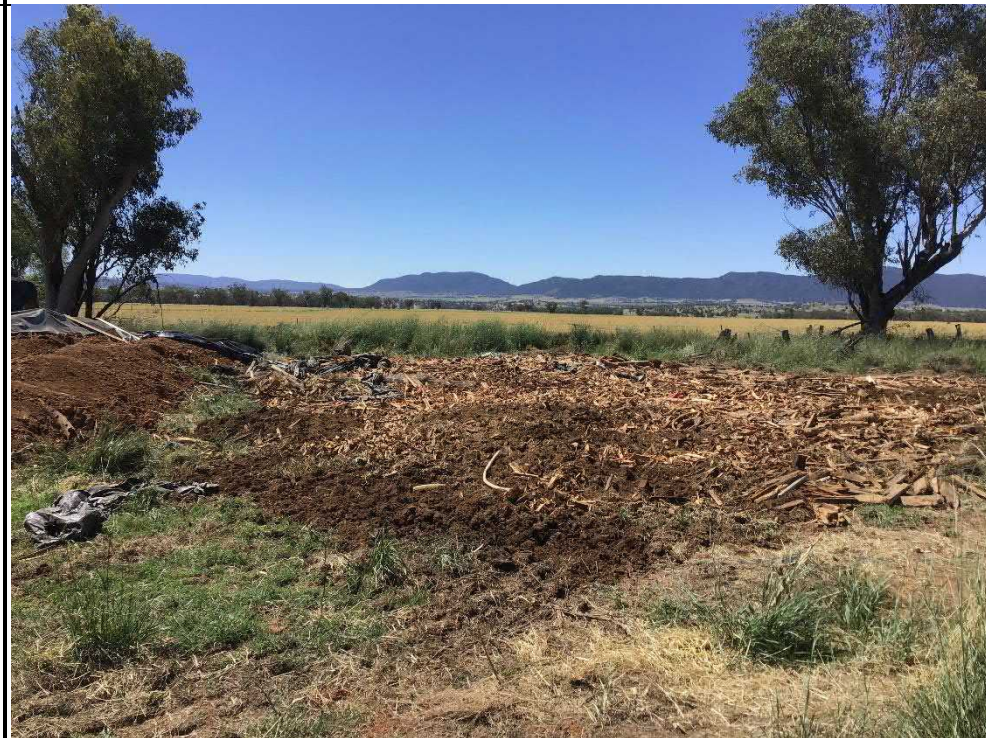
Photograph 20 – Timber stockpile spread and compacted into surface within the remediation area, facing north from TP 201

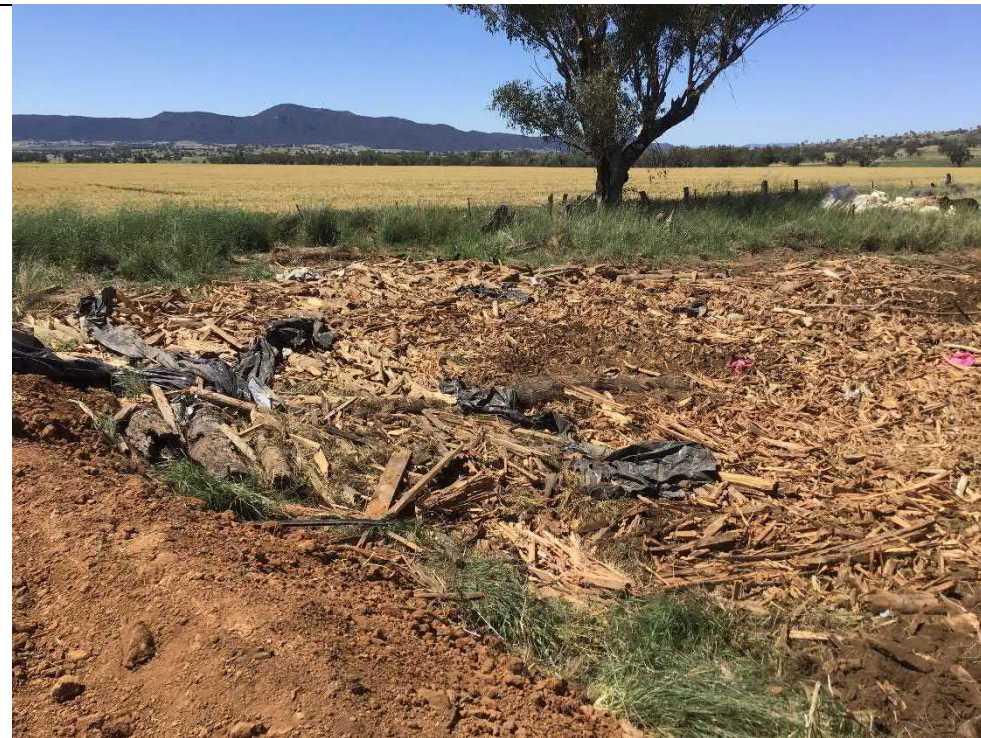
Photograph 22 – Timber stockpile spread and compacted into surface within the remediation area, facing north from adjacent TP202

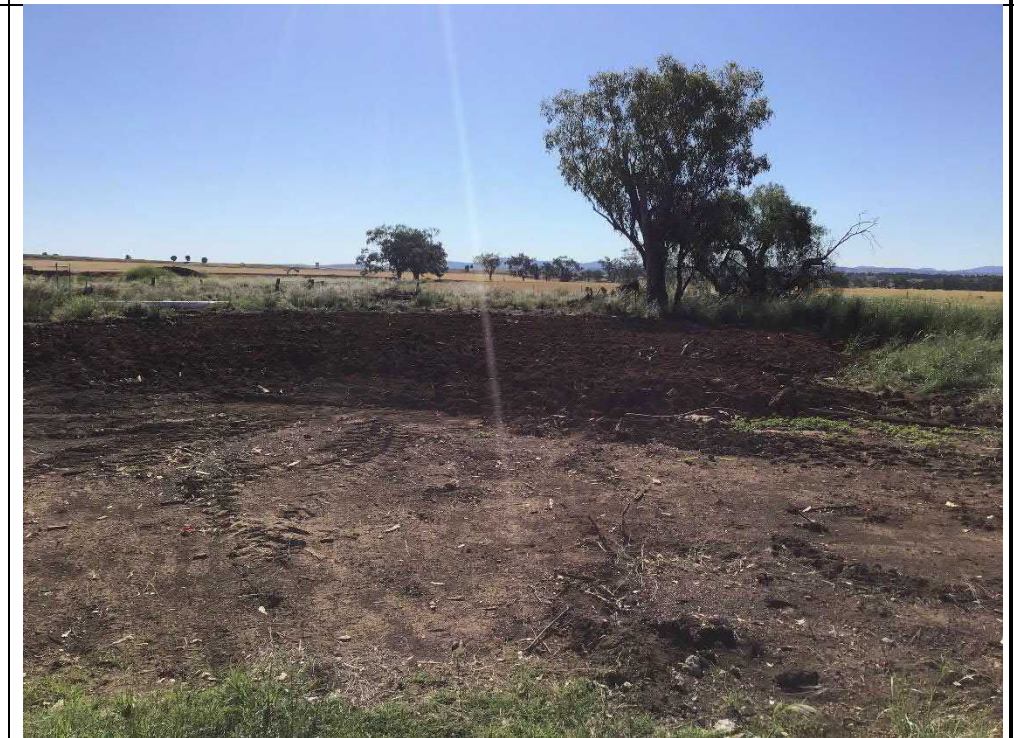
Photograph 24 – Unexpected finds stockpile spread within the remediation area to form part of the Earth Cover Layer of capping, from adjacent TP103

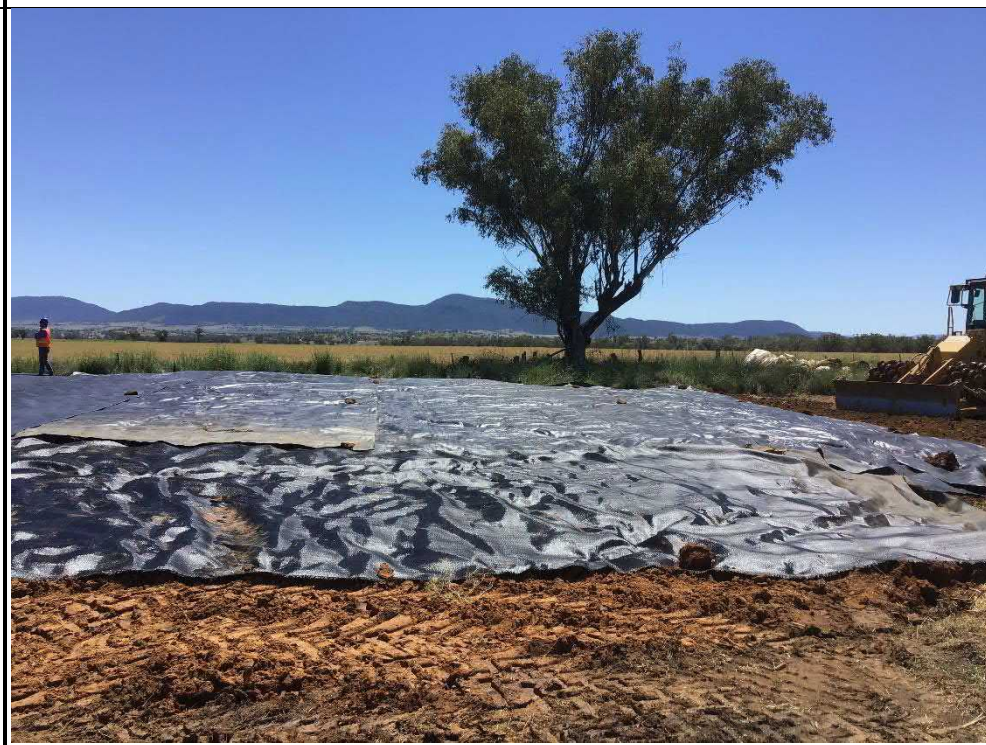
Photograph 25 – Marker layer over Earth Cover Layer, facing north from adjacent TP201

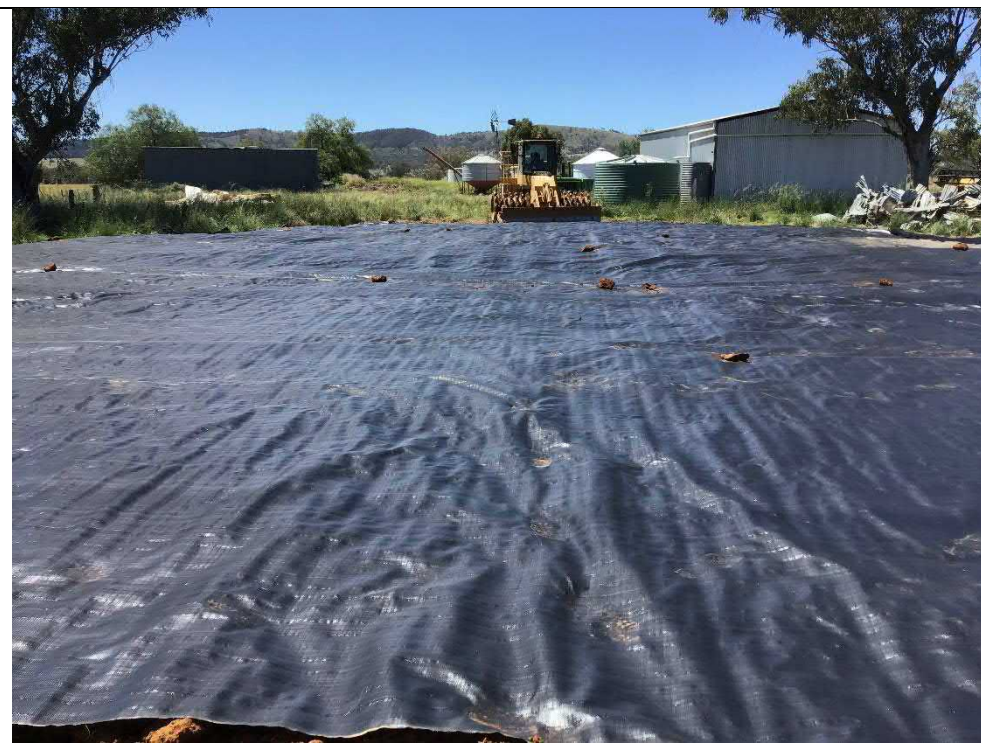
Photograph 27 – Marker layer over Earth Cover Layer, facing east from adjacent TP204

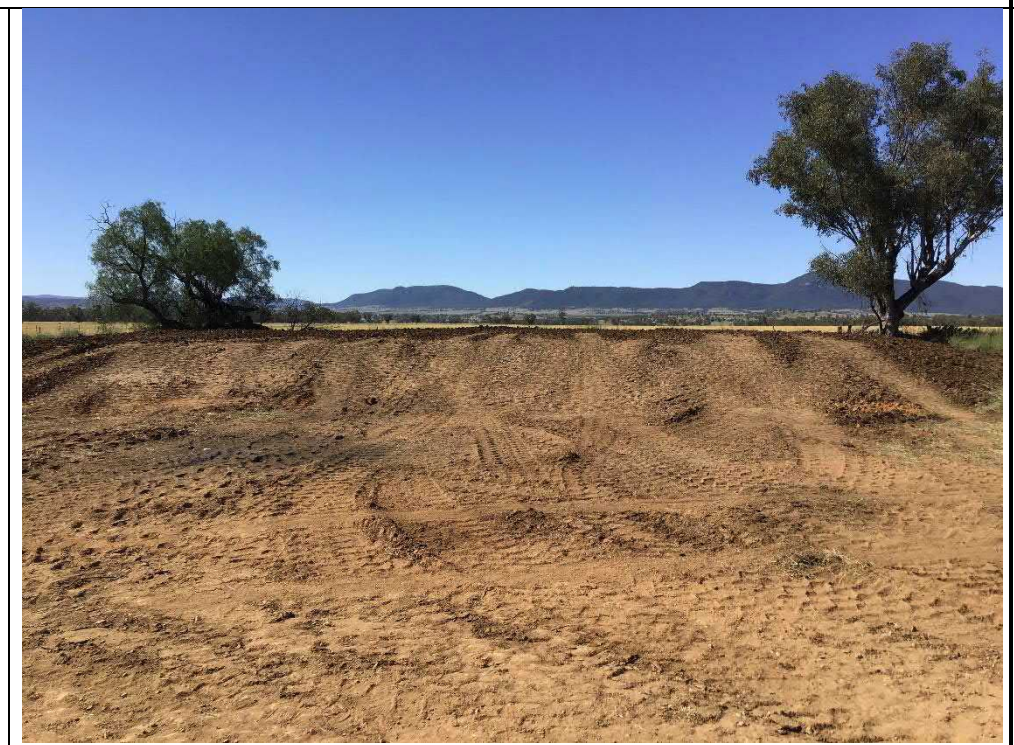
Photograph 29 – Low permeability clay layer, facing north adjacent TP202

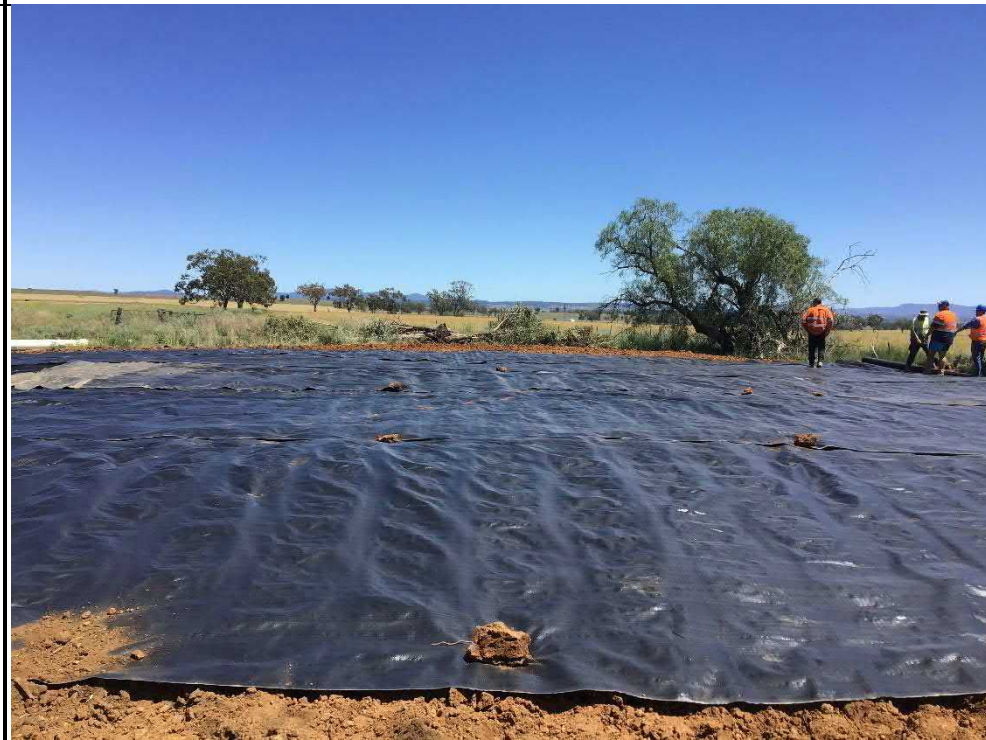
Photograph 26 – Marker layer over Earth Cover Layer, facing west from adjacent TP102

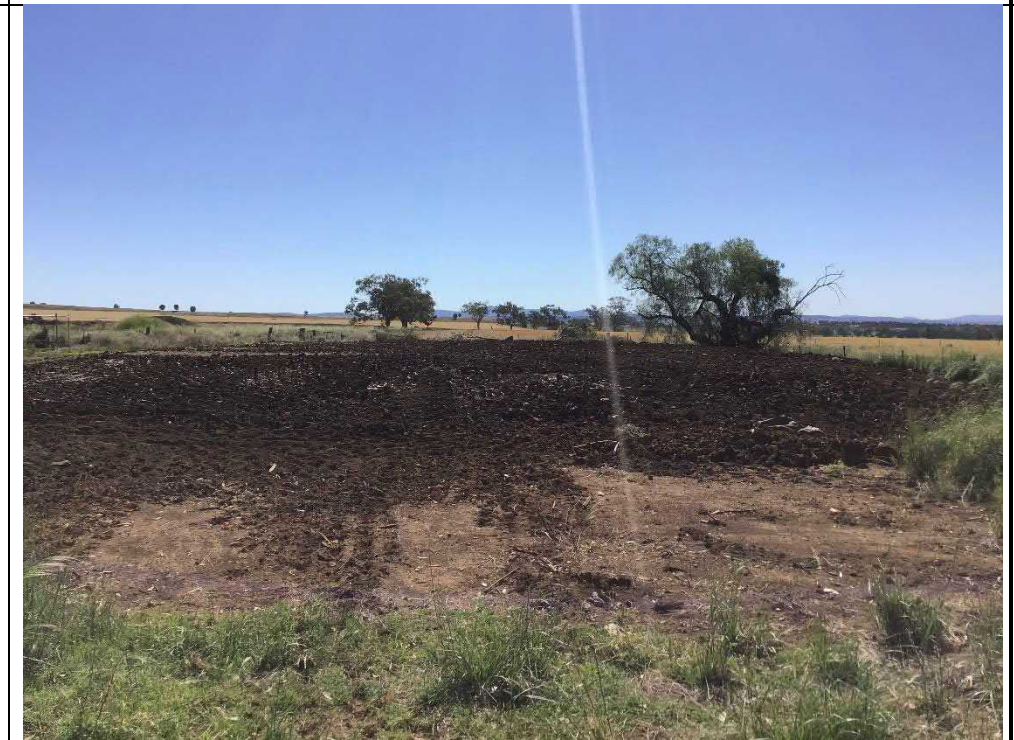
Photograph 30 – Low permeability clay layer, facing west adjacent TP202

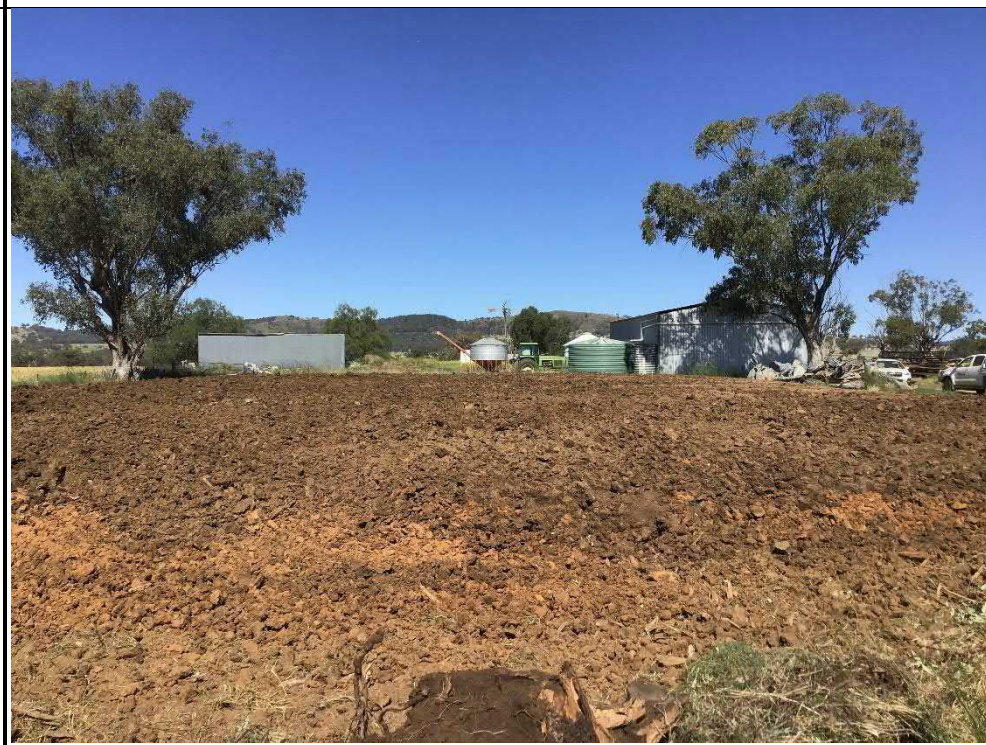
Photograph 31 – Low permeability clay layer, facing east adjacent TP205

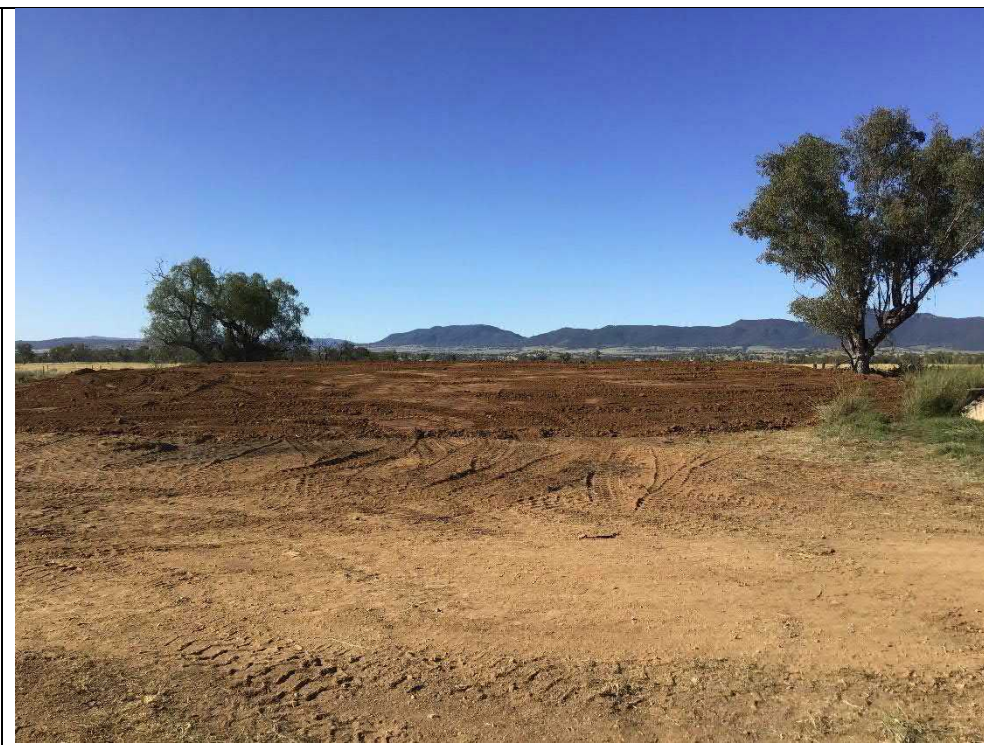
Photograph 33 – Topsoil layer, facing north

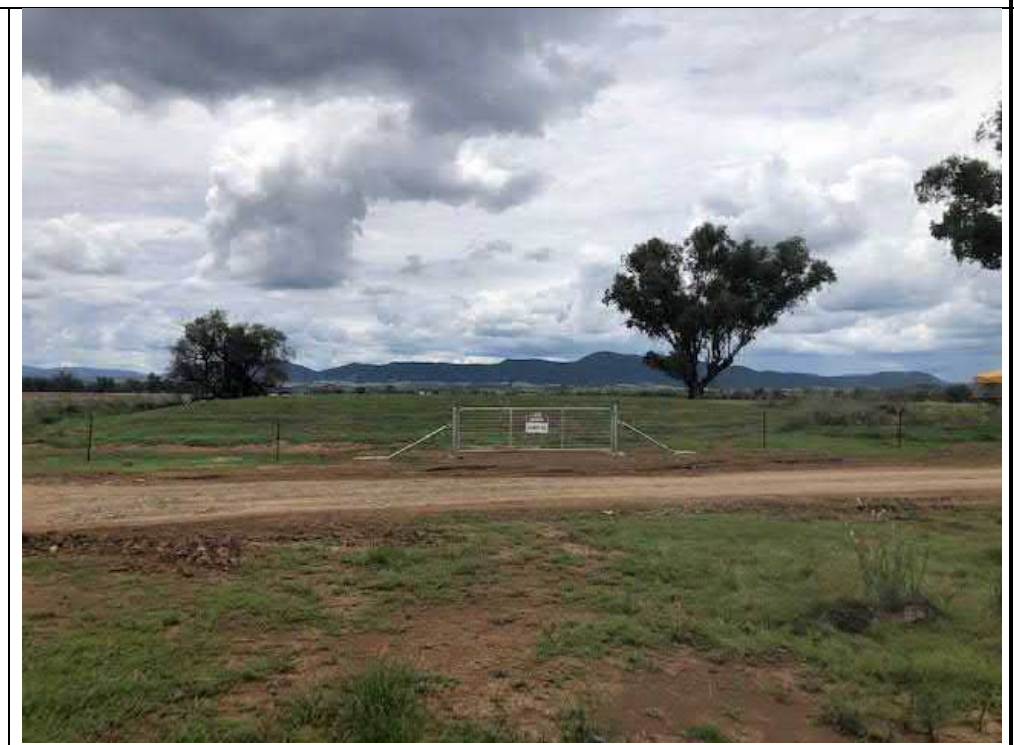
Photograph 35 – Capping area showing fencing and revegetation

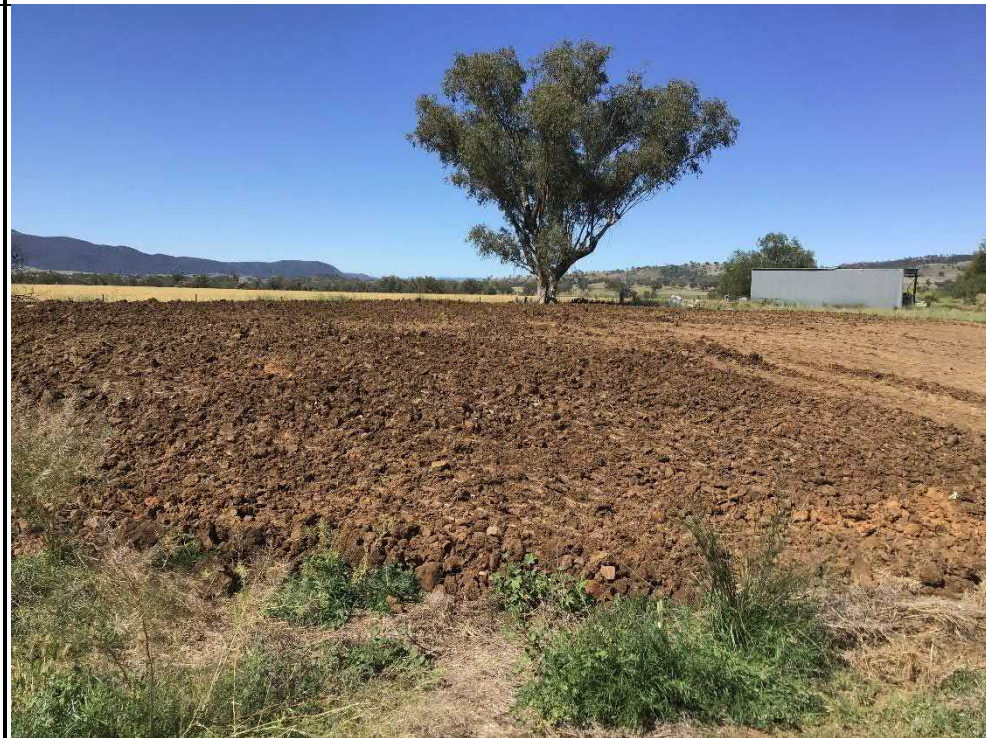
Photograph 32 - Low permeability clay layer, facing east adjacent TP205

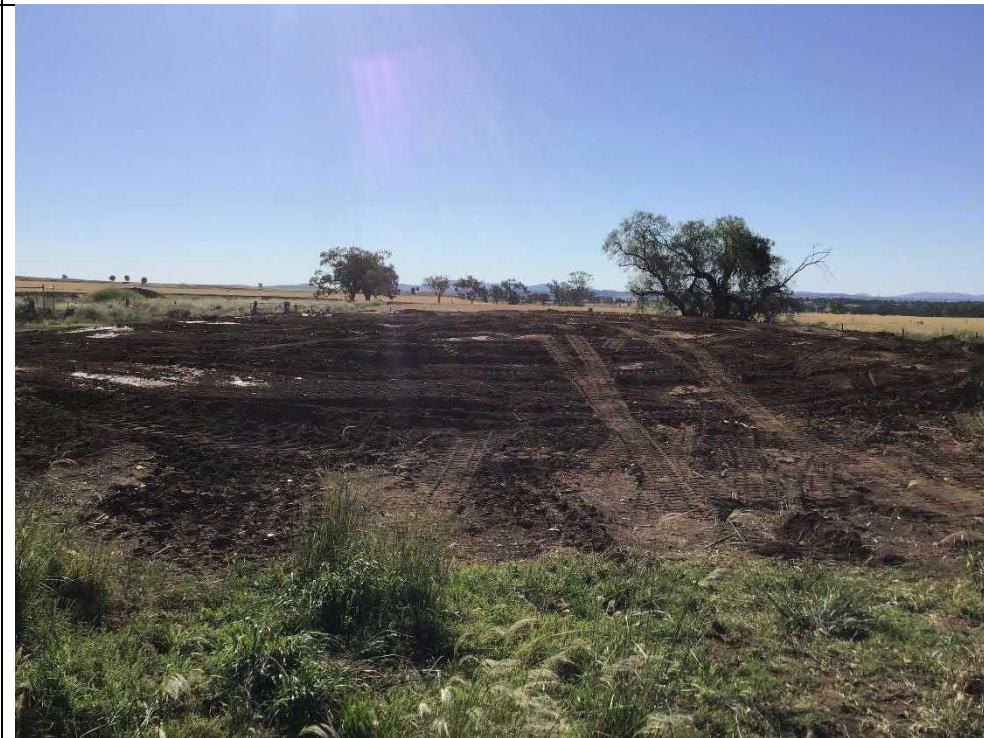
Photograph 34 – Topsoil layer, facing west

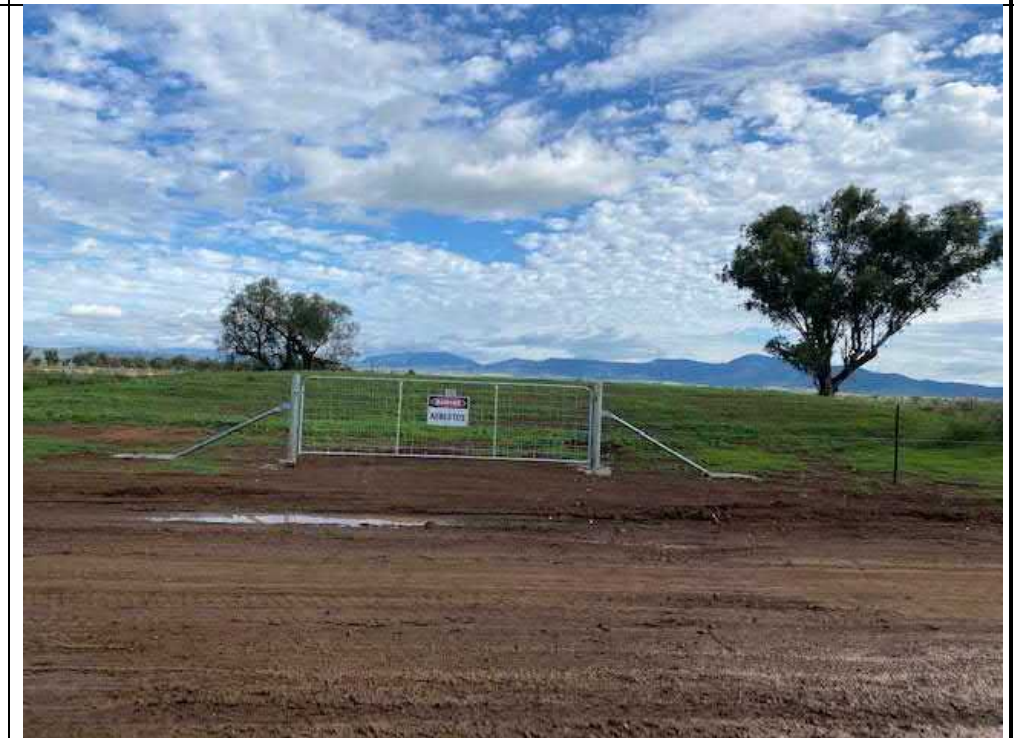
Photograph 36 – Capping area showing fencing with asbestos signage and revegetation
