# Long-Term Environmental Management Plan

### **Rushes Creek Poultry Production Farm**

#### **PtoTen Pty Ltd**

31 January 2024

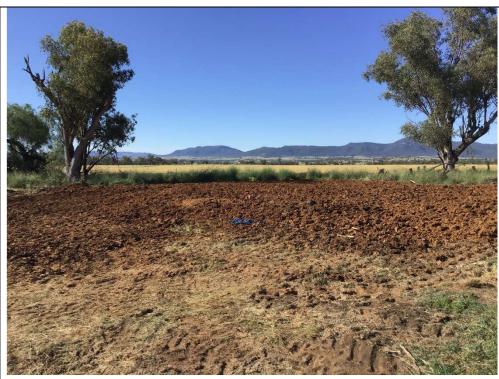
Photograph 20 – Timber stockpile spread and compacted into surface within the remediation area, facing north from TP 201

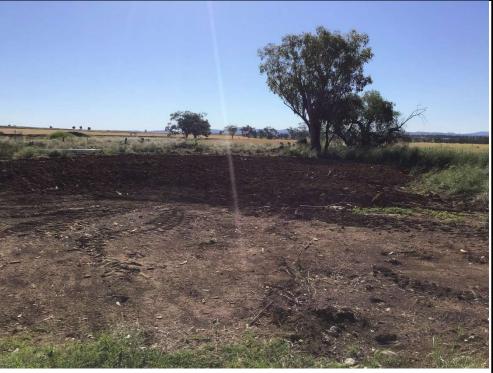
Photograph 24 – Unexpected finds stockpile spread within the remediation area to form part of the Earth Cover Layer of capping, from adjacent TP103

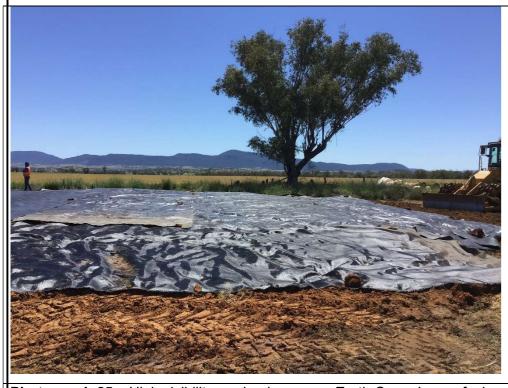
Photograph 25 – High visibility marker layer over Earth Cover Layer, facing north from adjacent TP201

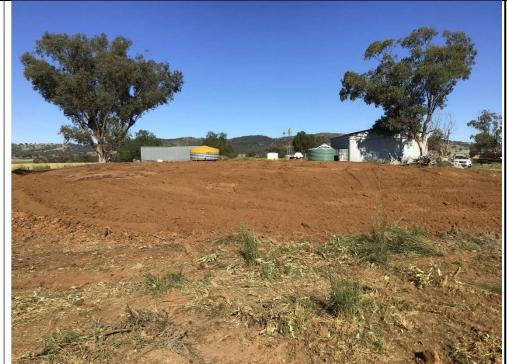
Photograph 32 - Low permeability clay layer, facing east adjacent TP205

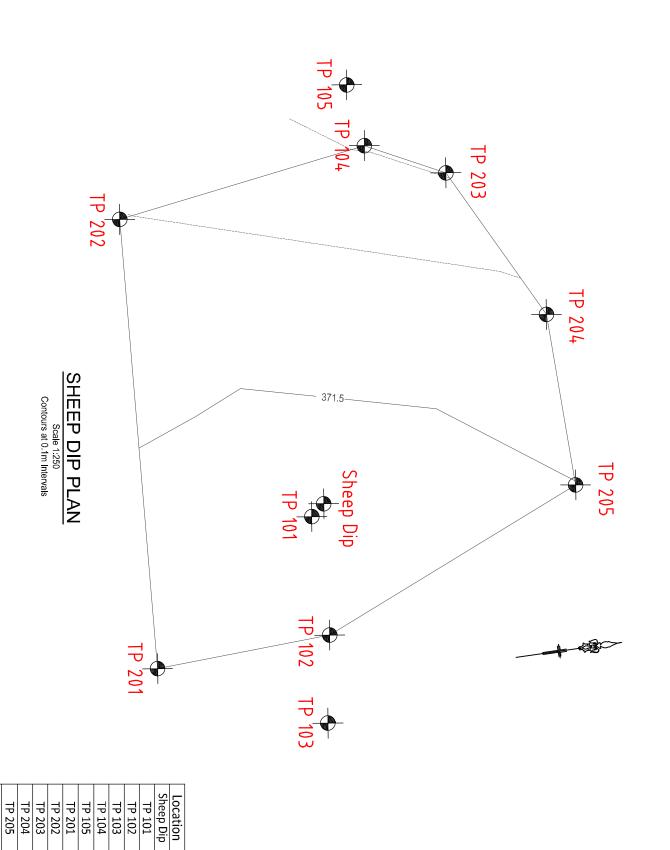
22.10.2021 - SHEEP DIP CO-ORDINATES - ORIGINAL CONDITION 01 of 01

- This sketch is to be read in conjunction with the letter and / or email issued for these works
- N The information provided in this sketch is to assist in the
- ယ In the event that there are ERRORS or CONFLICTING information provided you MUST contact the Office for immediate
- All dimensions are in millimeters unless stated otherwise
- Ò This site survey was carried out using Differential Global Navigational Satellite System technology (GNSS) on 22.10.2021
- ဂ Test Pit reference numbers and approximate locations have been taken from SLR sketch (App A\_F3\_CappingExtent\_01.pdf) received on 22.10.2021
- The survey locations where on top of the disturbed (visual) areas
