# SITE REMEDIATION AND VALIDATION REPORT

Rushes Creek Poultry Production Farm, Rushes Creek Road, Rushes Creek, NSW 2346

SLR Ref: 610.30237.00000-R02 Version No: v2.0 February 2022

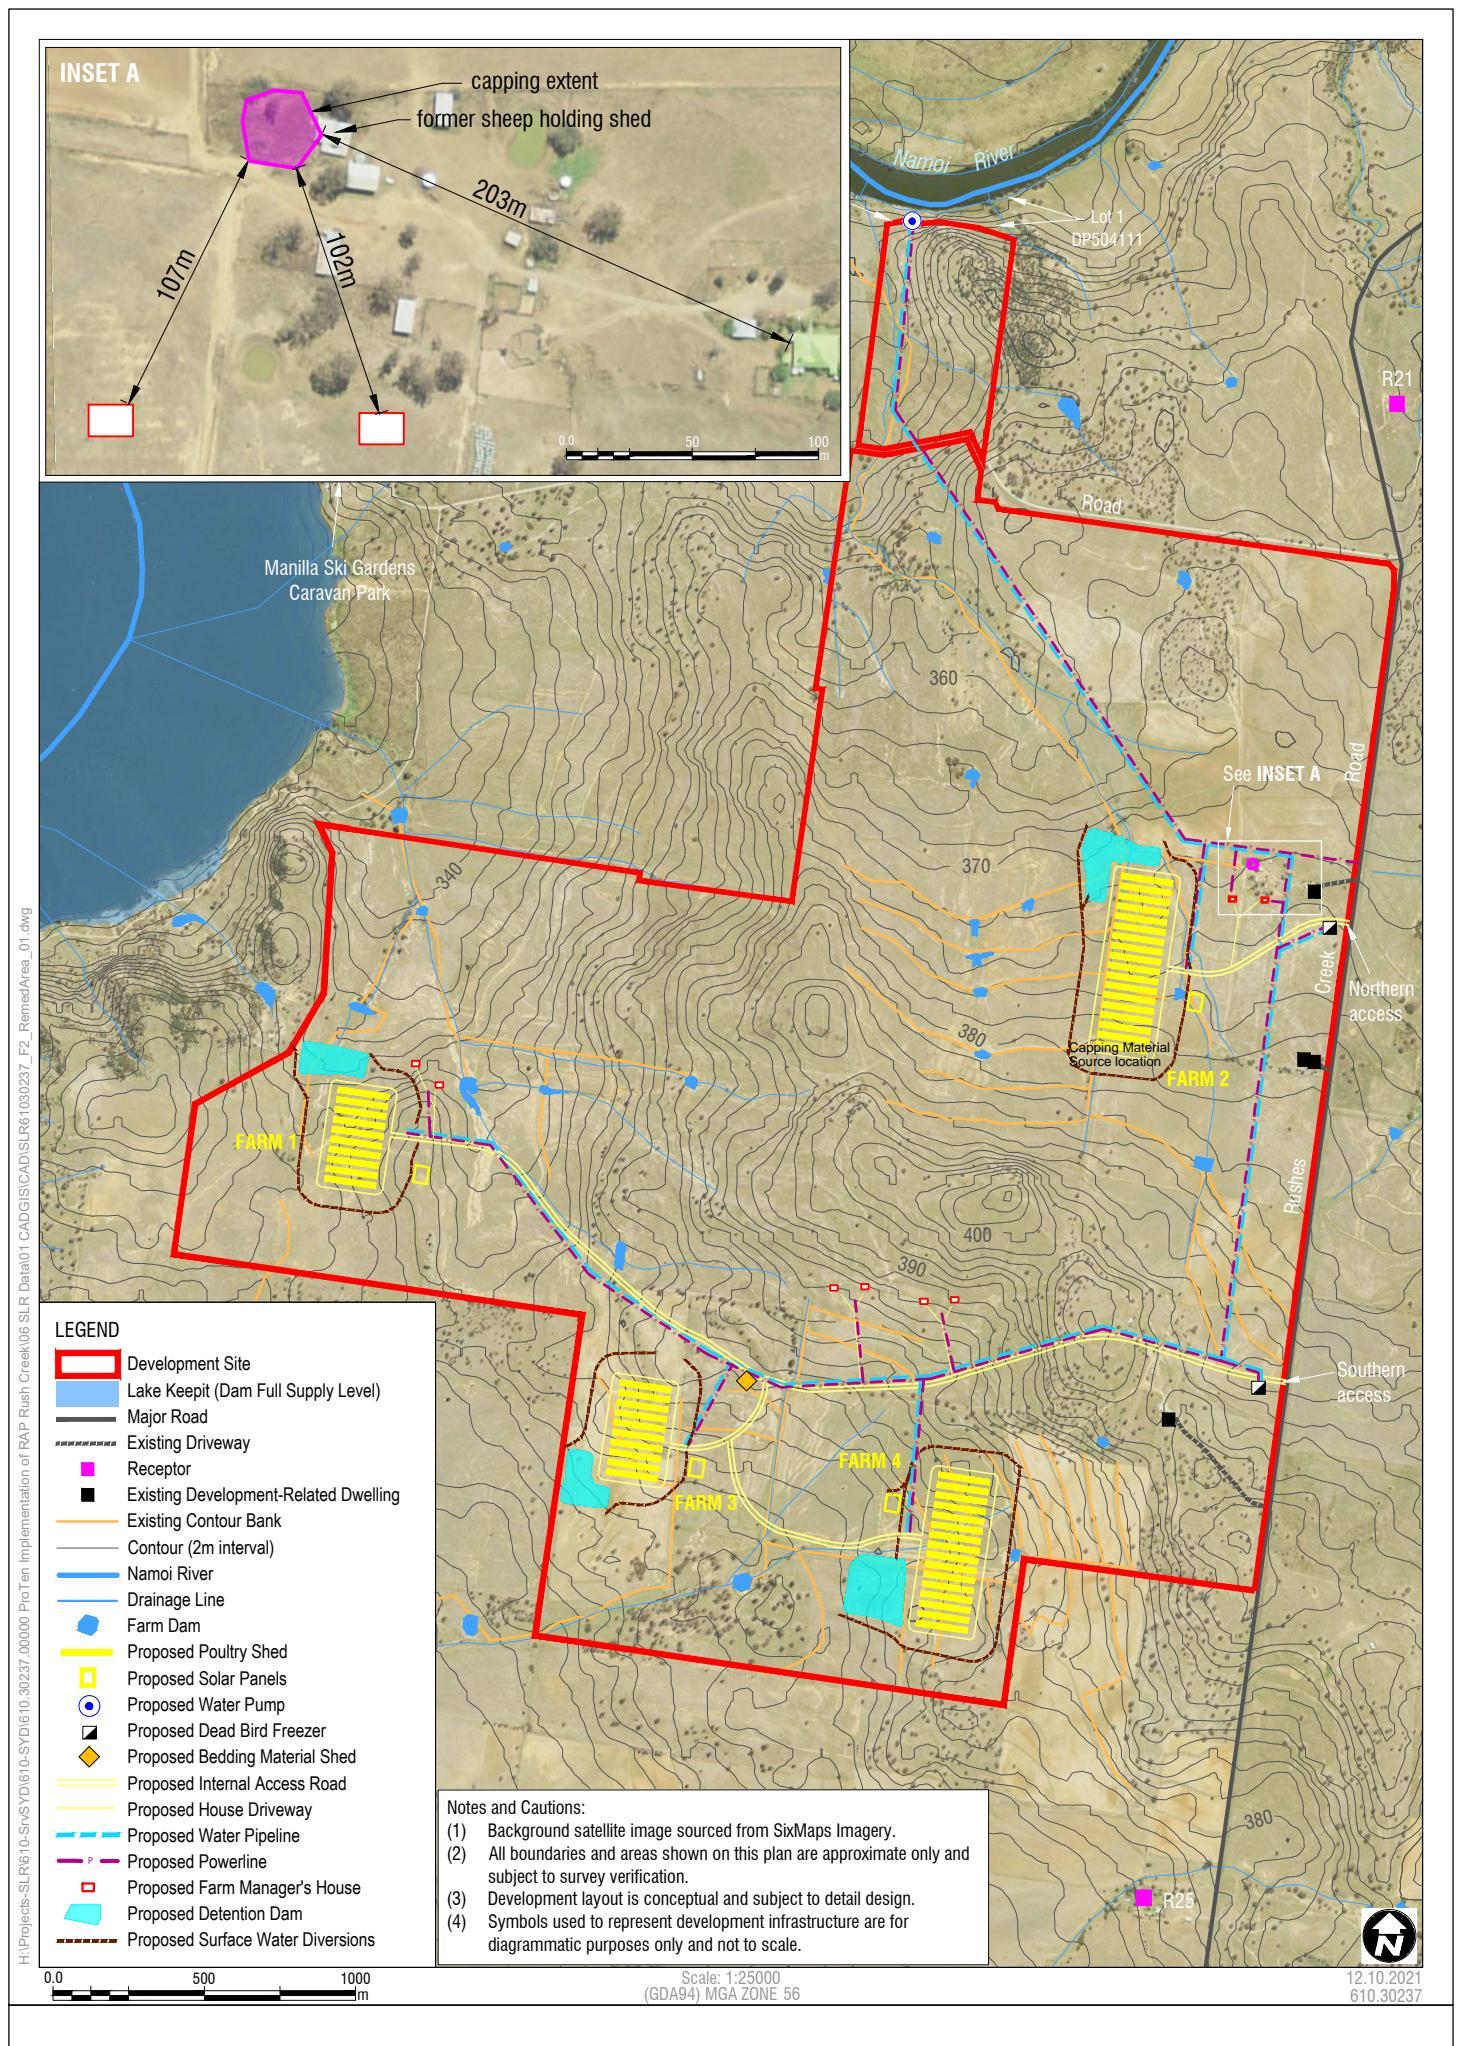
FIGURE 2

**Remediation Area**
