Rushes Creek Poultry Production Farm

Fire Safety Study

29 June 2021

Project Number: 12545704

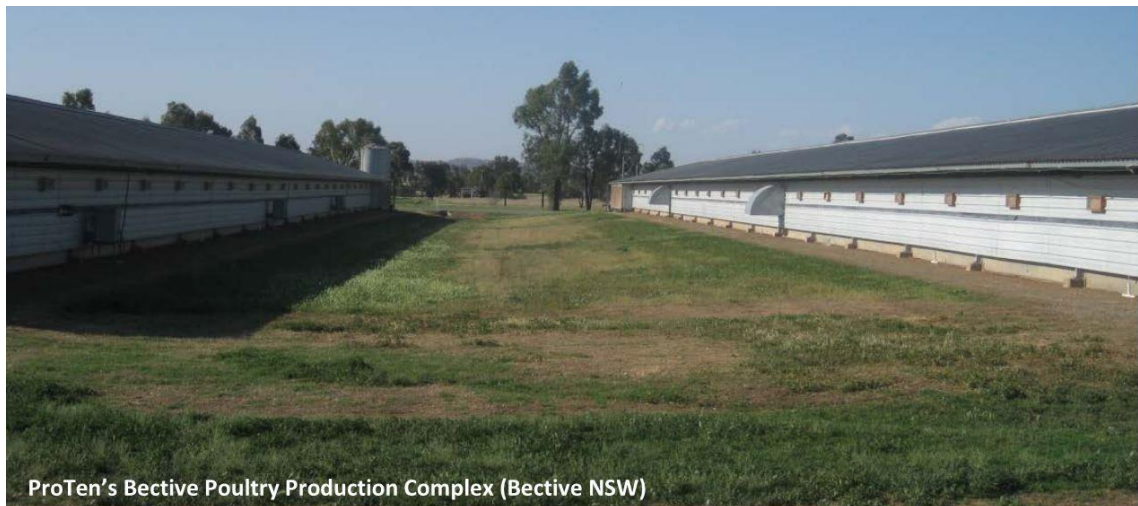
Figure 4: ProTen's Bective Poultry Production Complex (SLR, 2018)

Each of the farms will consist of 10 to 18 poultry sheds, with a total of 54 sheds on the Development Site. The sheds will be distributed laterally and achieve a separation distance of approximately 15 m between sheds.

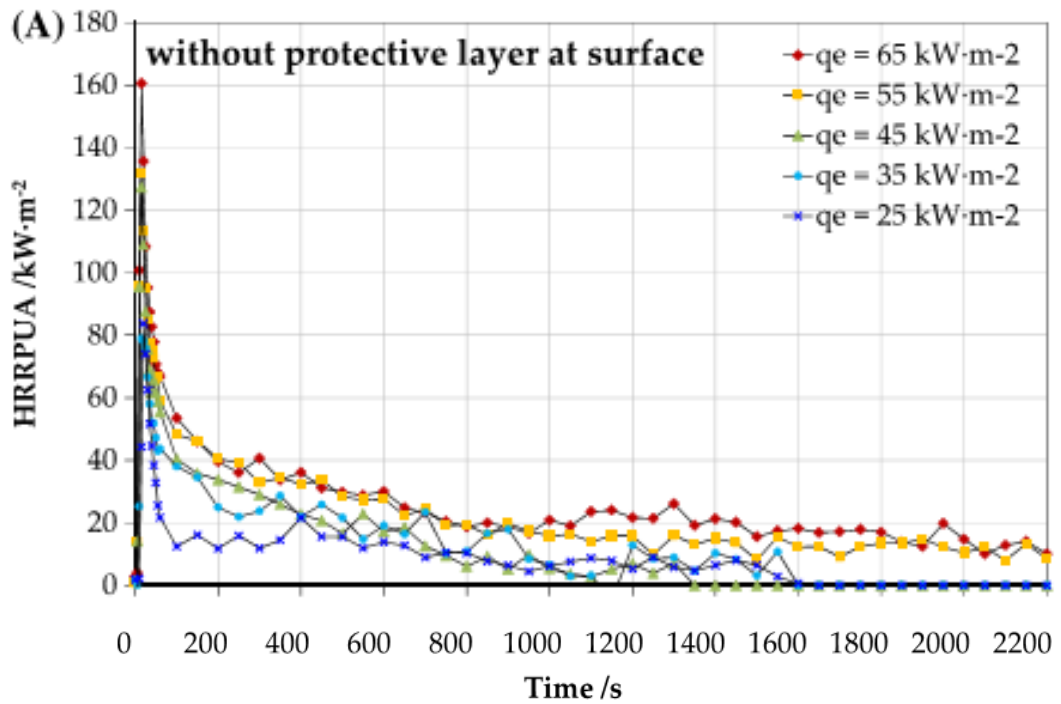
Figure 11: Heat release rate per unit area of 100-mm-thick PIR (Juan P.Hiadlgo, 2017)

During the study, when the specimen (100 mm thick) was exposed to a constant irradiance level of 65 kW/m², the HRRPUA of the panel (without protective layer at surface) peaked at 160 kW/m². This occurred within the first few minutes of exposure (during the flaming combustion stage) as shown in Figure 10, after which it decayed below 60 kW/m² represented by the formation of a char layer and transition of the pyrolysis front towards the inner depths.

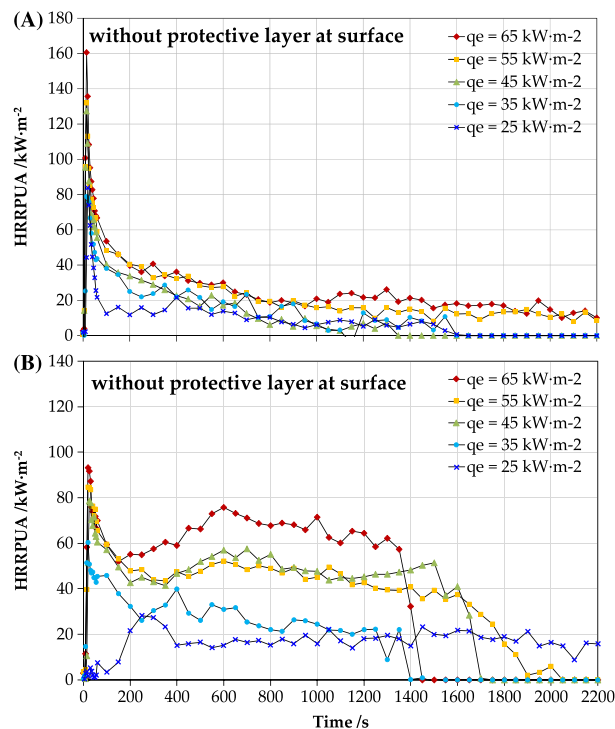
FIGURE 5 Heat release rate per unit area of 100-mm-thick A, PIRa and B, PF samples without protective layer at different external heat fluxes. Average from 2 repetitions. PIR, polyisocyanurate; PF, phenolic foam [Colour figure can be viewed at wileyonlinelibrary.com]
